Mayne Tree Expert Company, Inc.

February 8, 2022

Mr. Paul Goswamy
890 Upland Rd.
Redwood City, CA 94062

RE: ARBORIST REPORT

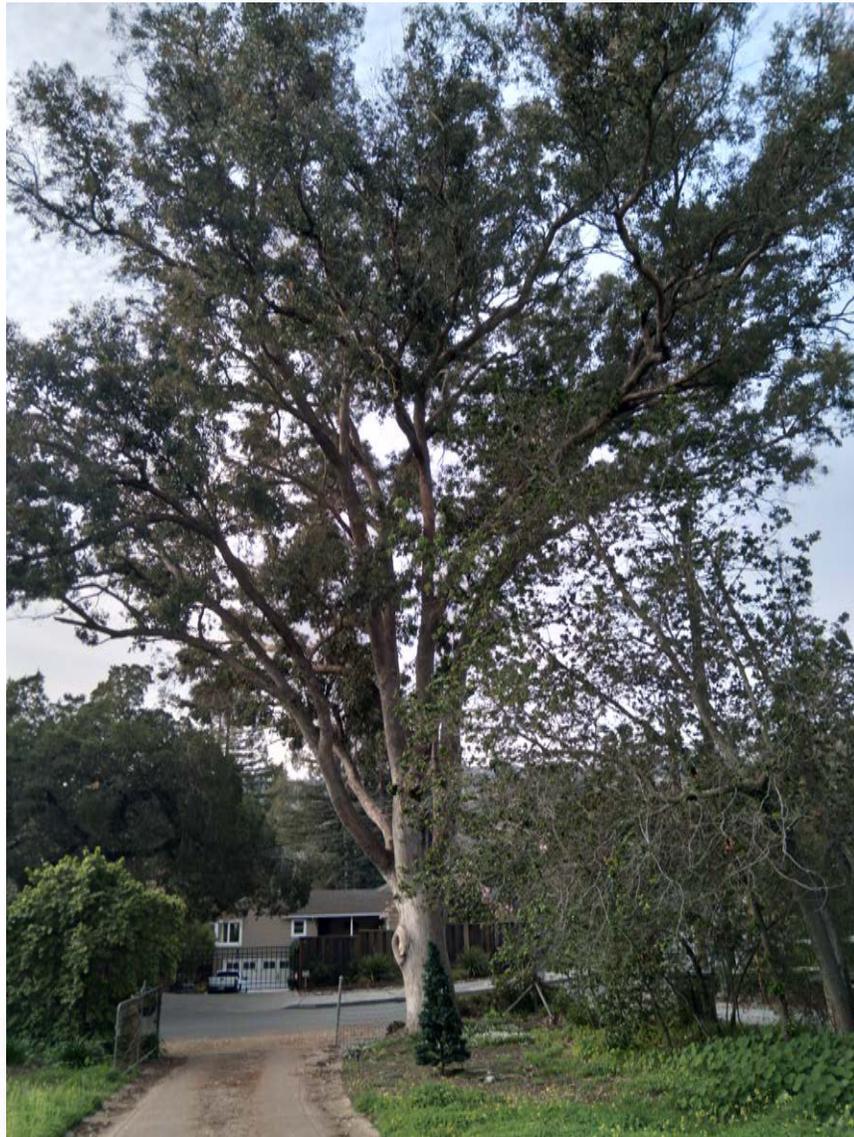
Tree #1 is a Red Gum Eucalyptus located near the front left corner of the property. Soil and other organic material cover the root crown. There is a cavity at 5 feet on the east side of the trunk that is partially filled with broken glass from an art installation. It has multiple attachments at 10 feet, heavy lateral limbs, and a moderate amount of interior deadwood. The canopy is partially growing over high voltage lines it has fair vigor and poor form.

I recommend routine pruning that should include end weight reduction, deadwood removal and removal of the glass from the cavity. It is a good idea to contact the utility provider about fire hazards associated with Eucalyptus trees. This tree is a good candidate for routine pruning or removal by the vegetation management division of the utility service.

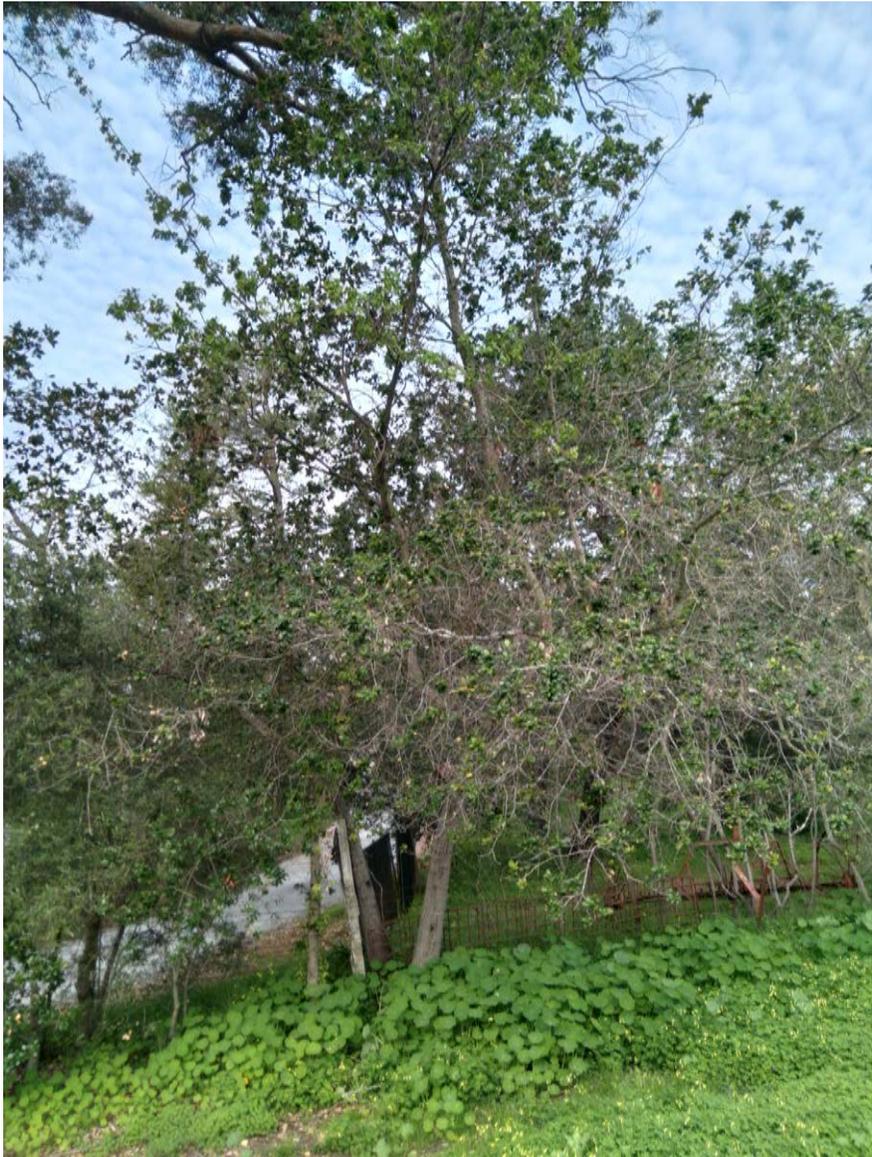
Tree #2 is a Coast Live Oak located along the western property line. Soil, grass, and other organic material cover the root crown. The trunk straddles the property line with one stem on the neighboring property and one stem on the client's property. Fencing is embedded in the trunk, there is oozing on the lower east side of the trunk, an abundance of interior deadwood and a thinning canopy. Overall, this tree has poor form and vigor.

I recommend removal of this tree as it has several significant defects and poor vigor. Contacting the neighboring property owner is advised.

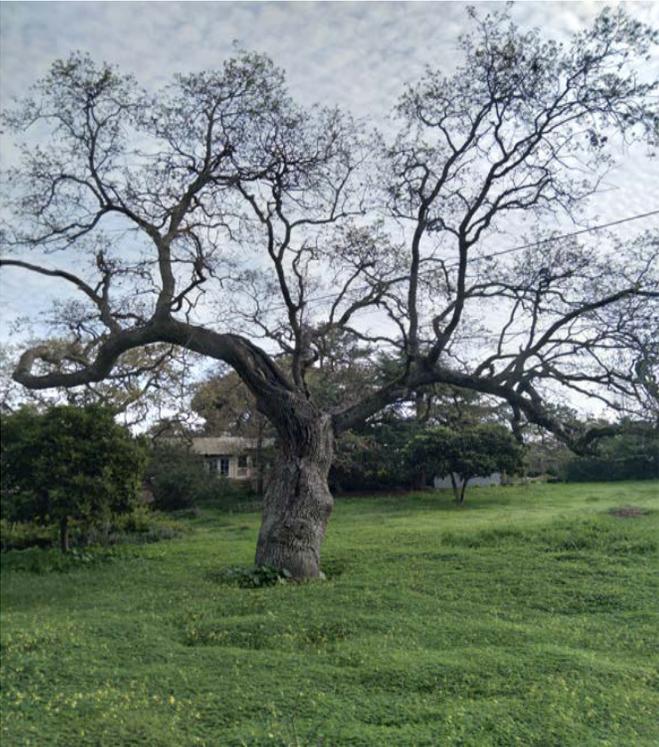
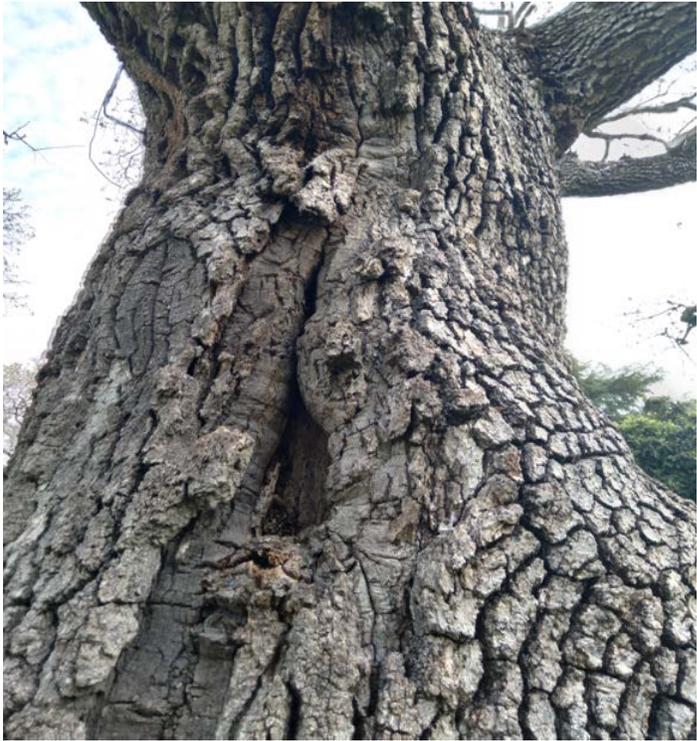
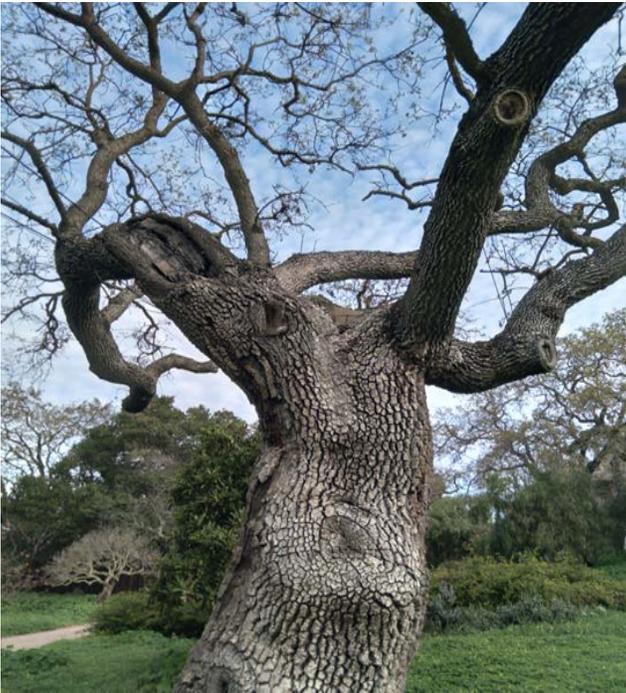
Tree #3 is a Valley oak located in near the left center of the lot. An abundance of soil and other organic material cover the root crown. There is significant decay in the lower trunk with several large cavities present, utility lines attached to the northwest side of the trunk, a three-stem attachment at 12 feet. Very poor form, fair vigor.

Due to the large amount of decay in the lower trunk I believe this tree poses an unacceptable risk to anyone congregating under its canopy for long periods of time. If the area under its canopy is to be used more frequently a thorough inspection should be performed of the lower trunk.

At present this tree has several significant defects that would pose a substantial hazard to anyone under its canopy. However, the area under its canopy is rarely used. To further reduce the likelihood of failure I recommend routine tree maintenance that should include exposing the root crown, removal of the utility lines from the trunk, removal of the large deadwood and end weight reduction of the heavier lateral limbs.

Special inspections for **trees #3 and #26** should take place to confirm the structural integrity of the lower trunks and better decide what is an acceptable risk for the homeowner.

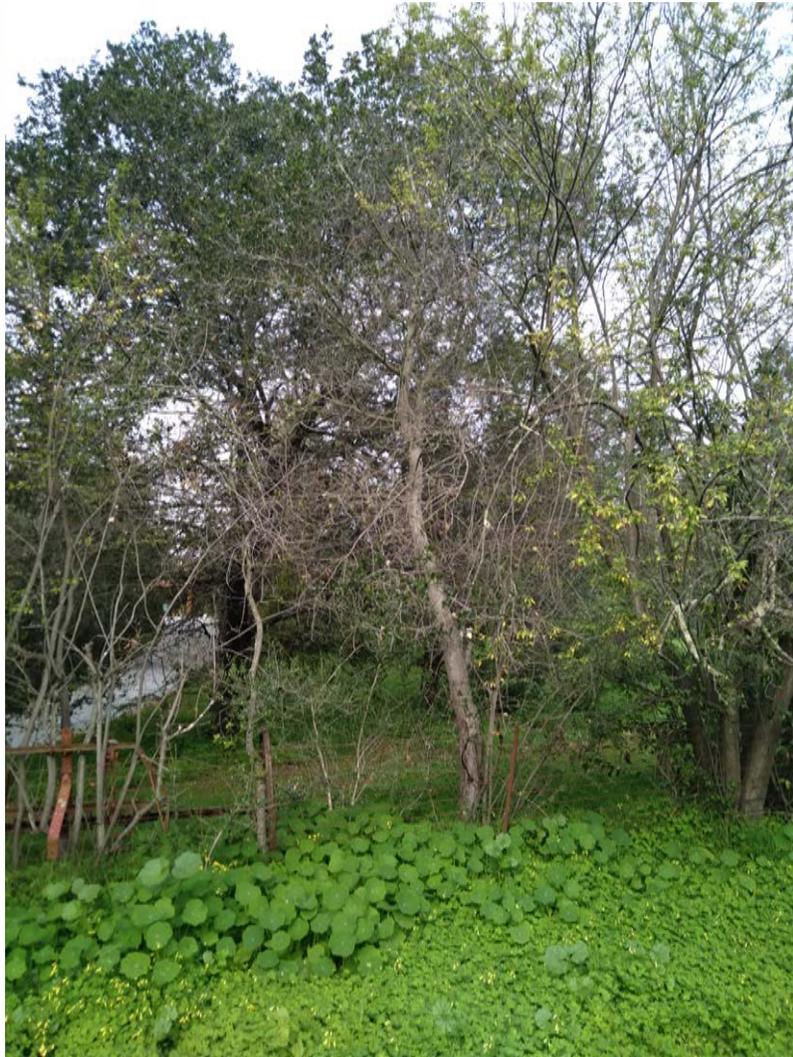
Tree #4 is a Coast Live oak located along the west side of the property. Soil and other organic material cover the root crown of this tree. It is located on the neighboring property, leans to the west, has an abundance of interior deadwood, fair vigor, and poor form.

No work is recommended at this time.

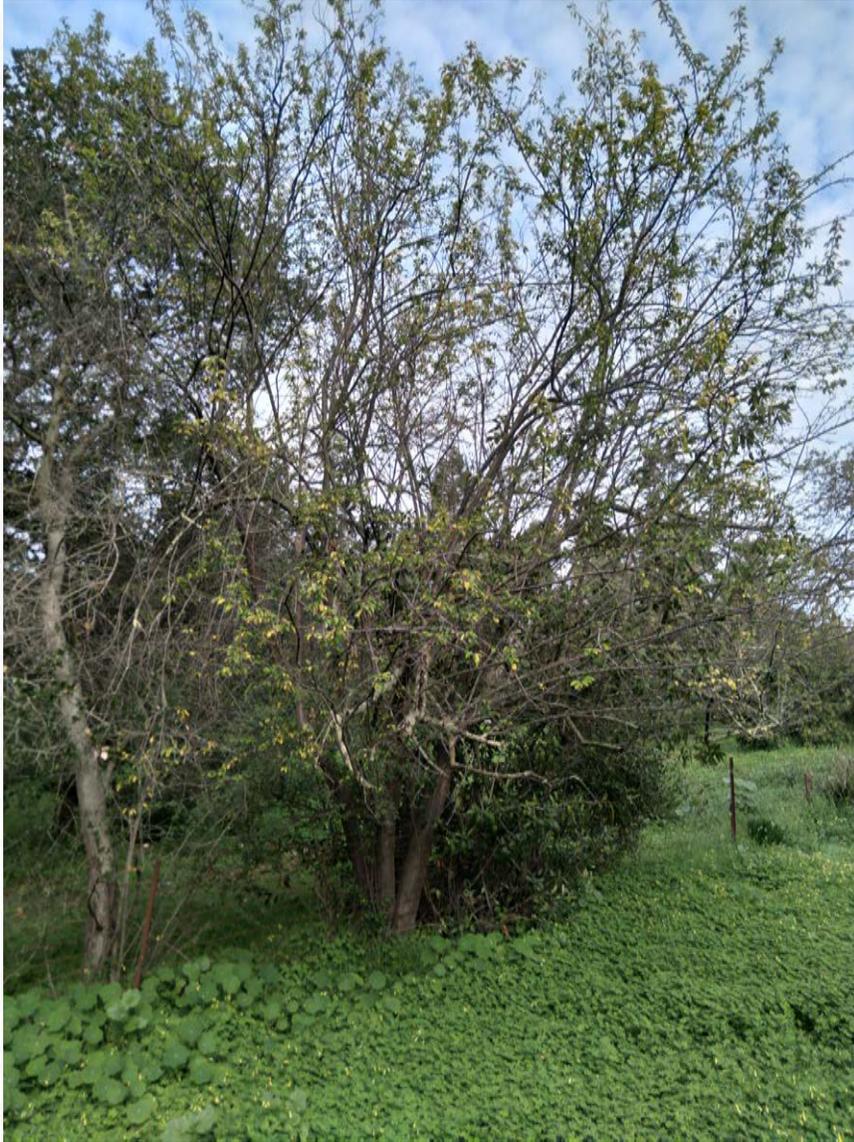
Tree #5 is a Plum located along the west property line. It is located on the neighboring property, has five to six stems at its base, poor form, and fair vigor.

I recommend side pruning the canopy as needed to reduce growth over the property line.

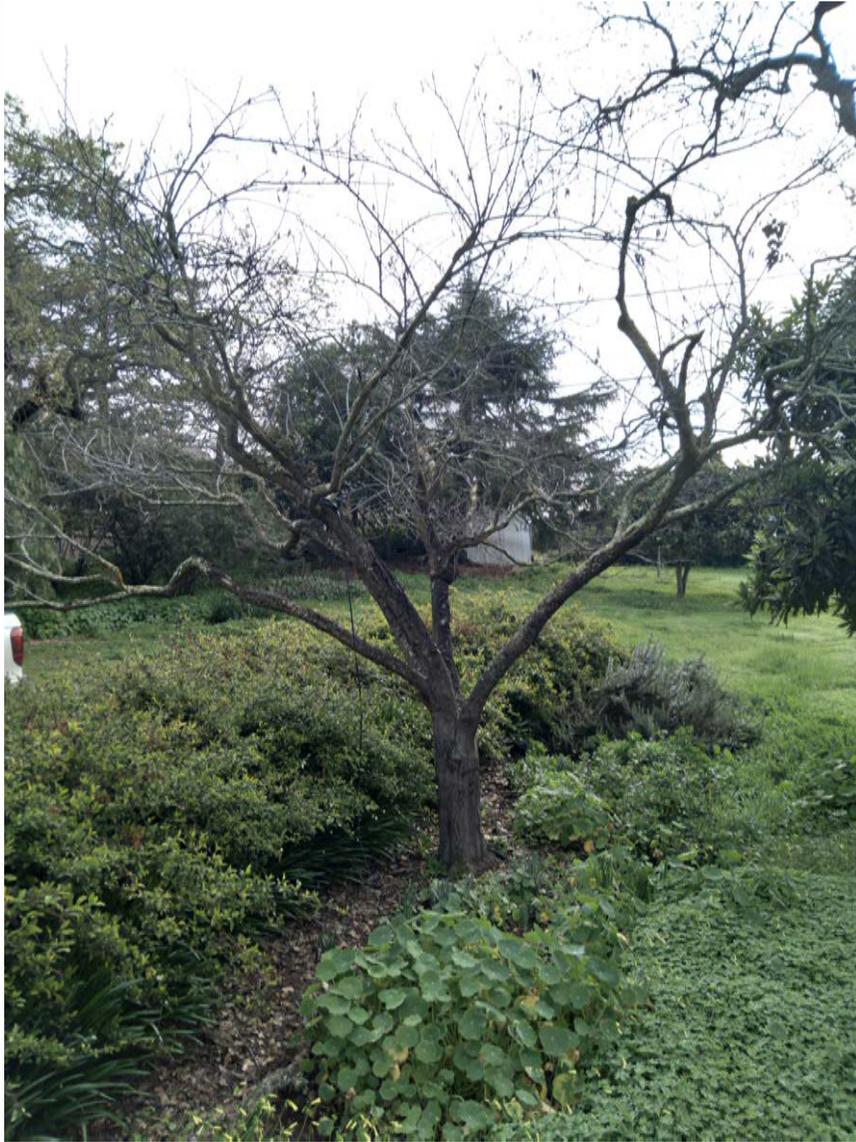
Tree #6 is a Plum located near the left center of the lot. Soil and other organic material cover the root crown of this tree. I measured the diameter of this tree below the three-stem attachment with included bark at 3½ feet. There is Fire blight in the canopy, Sunscald, and termite damage to several of the limbs. Overall, this tree has poor form and vigor.

I recommend removal of this tree due to its poor condition.

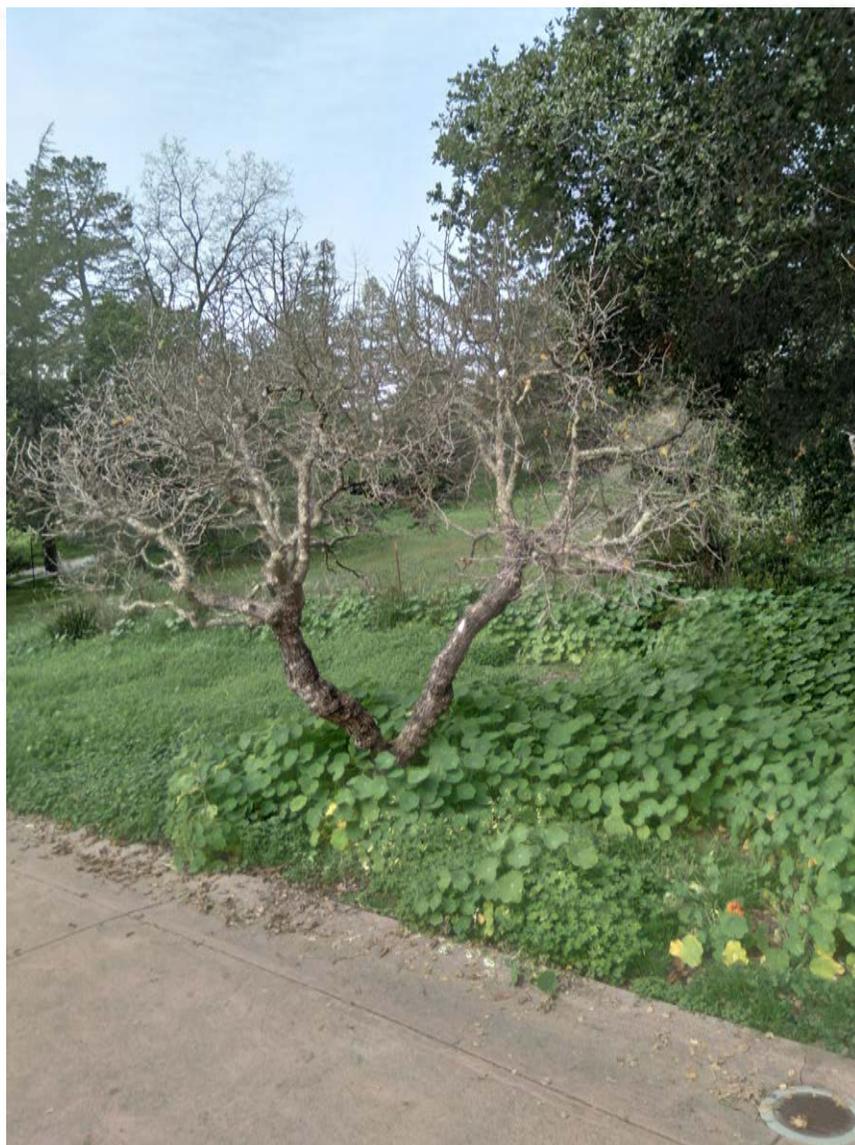
Tree #7 is a White Mulberry located along the left side of the driveway near the western border. This is a relatively small tree with good form created through routine shaping. Soil and other organic material cover the root crown, it has a two-stem attachment at 1-foot. Overall, this tree has fair vigor, and form.

I recommend routine tree maintenance that should include continuing with the shaping and regular irrigation.

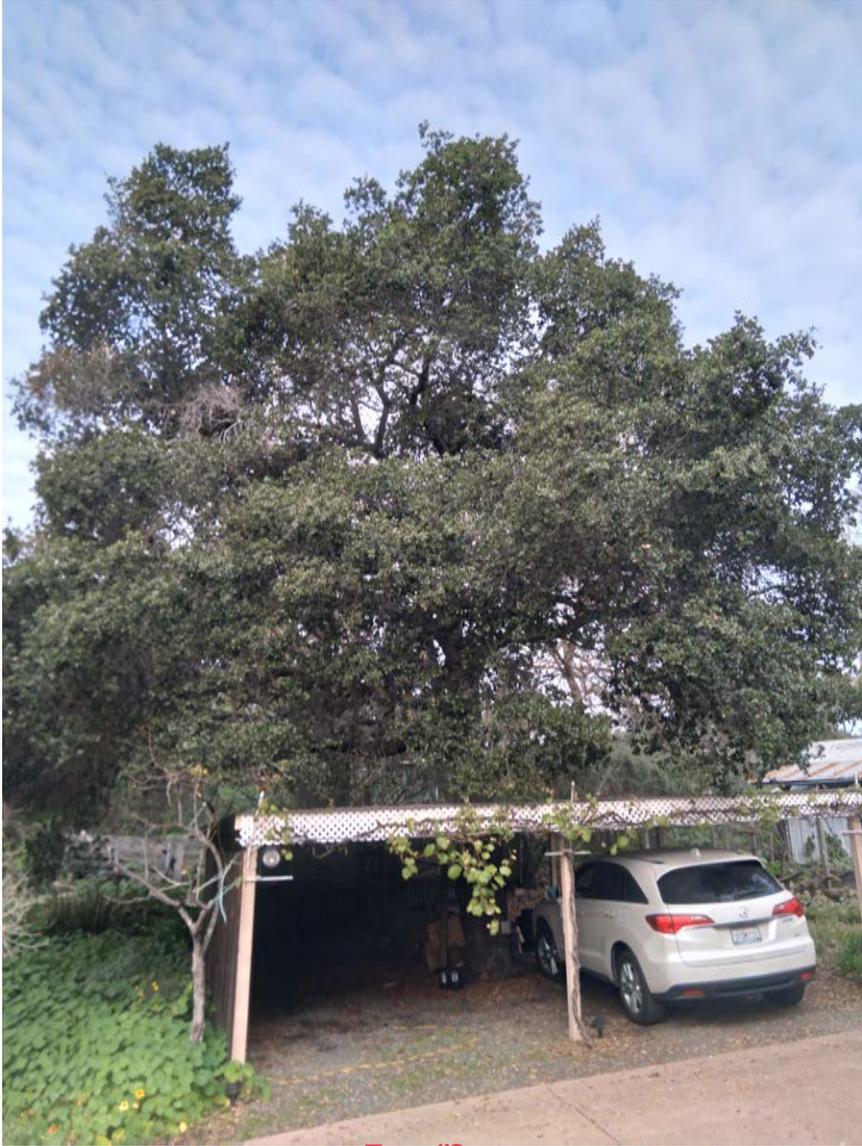
Tree #8 is a Coast Live Oak located along the left side of the property growing through the roof of a carport. Soil and other organic material cover the root crown, it has a cavity at 4 feet on the west side of the trunk, a codominant attachment at 15 feet, a moderate amount of interior deadwood. Overall, this tree has good vigor and fair form.

Due to its location this tree has the potential to substantially damage the carport structure. I recommend, routine maintenance that should include exposing the root crown, cutting the roof away from the tree, and removal of the interior deadwood.

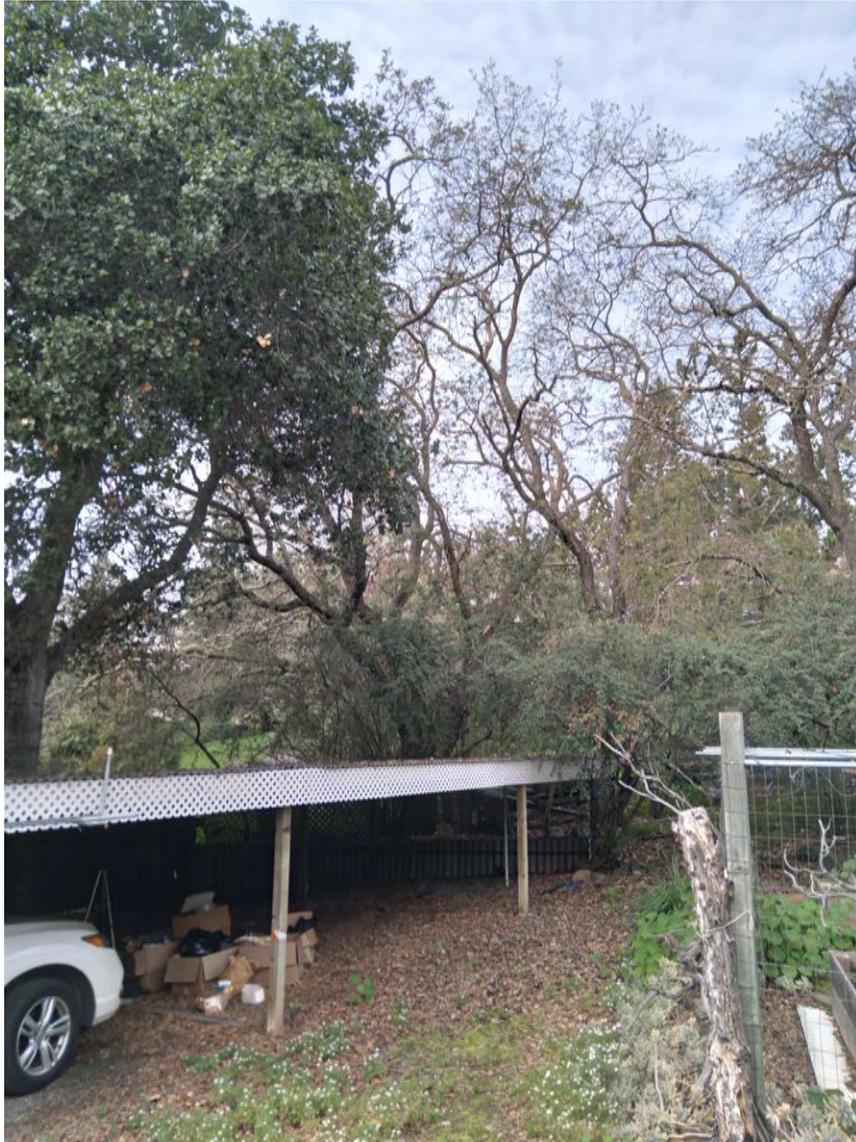
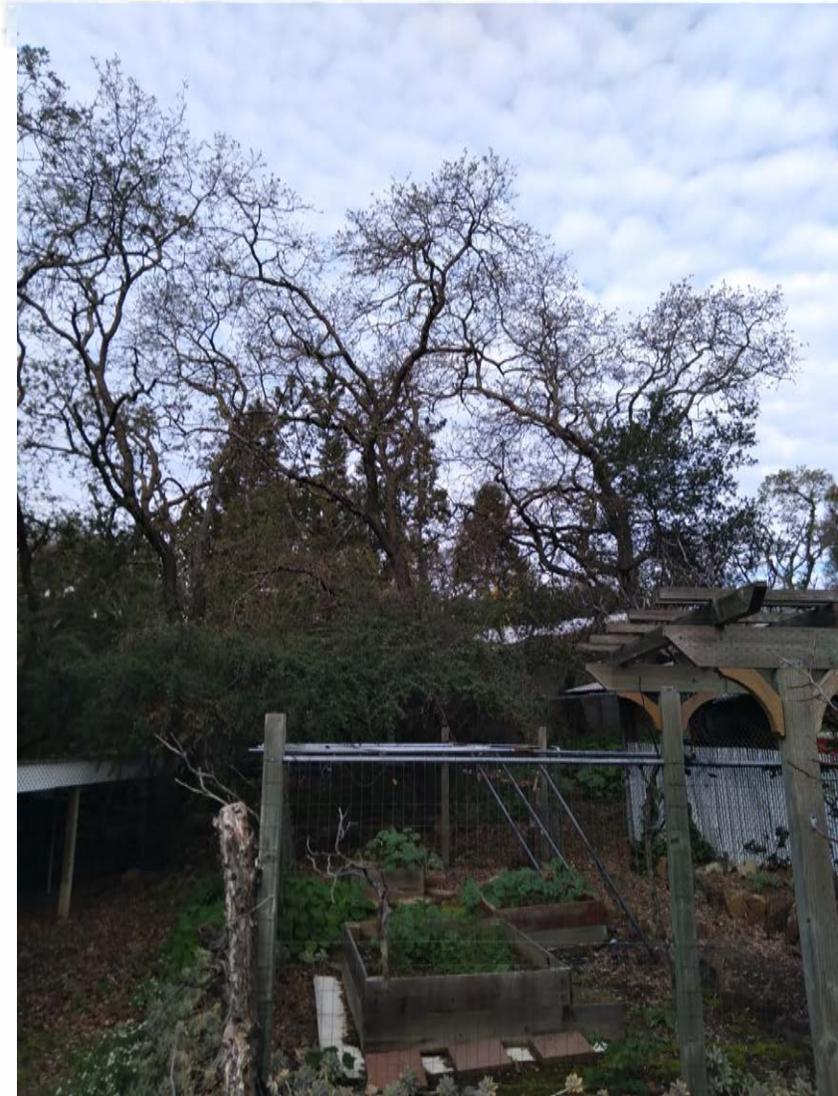
Trees #9 through #13 are all Valley Oaks located along the west property line on the neighboring property. These trees have covered root crowns, moderate amount of interior deadwood and little evidence of any recent tree maintenance.

I recommend routine tree maintenance that should include cutting back the upper canopies overhanging the client's property to maintain control of the growth.

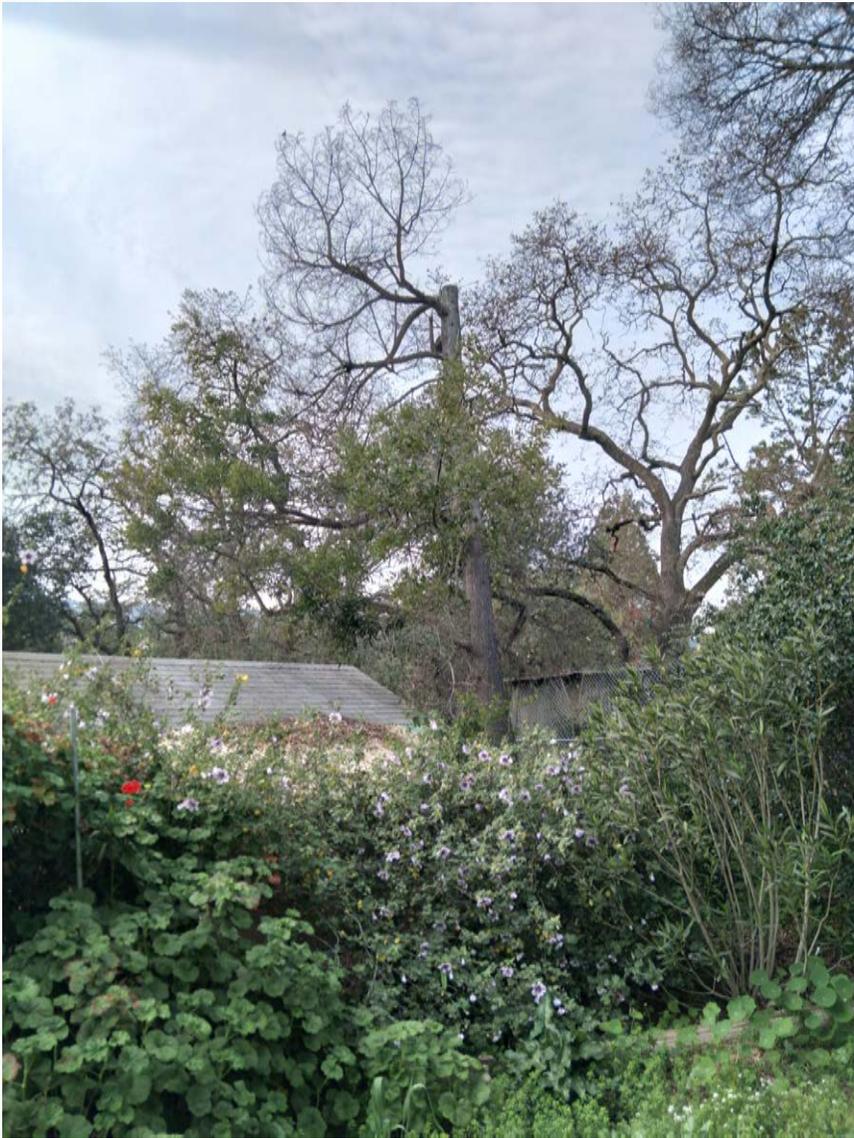
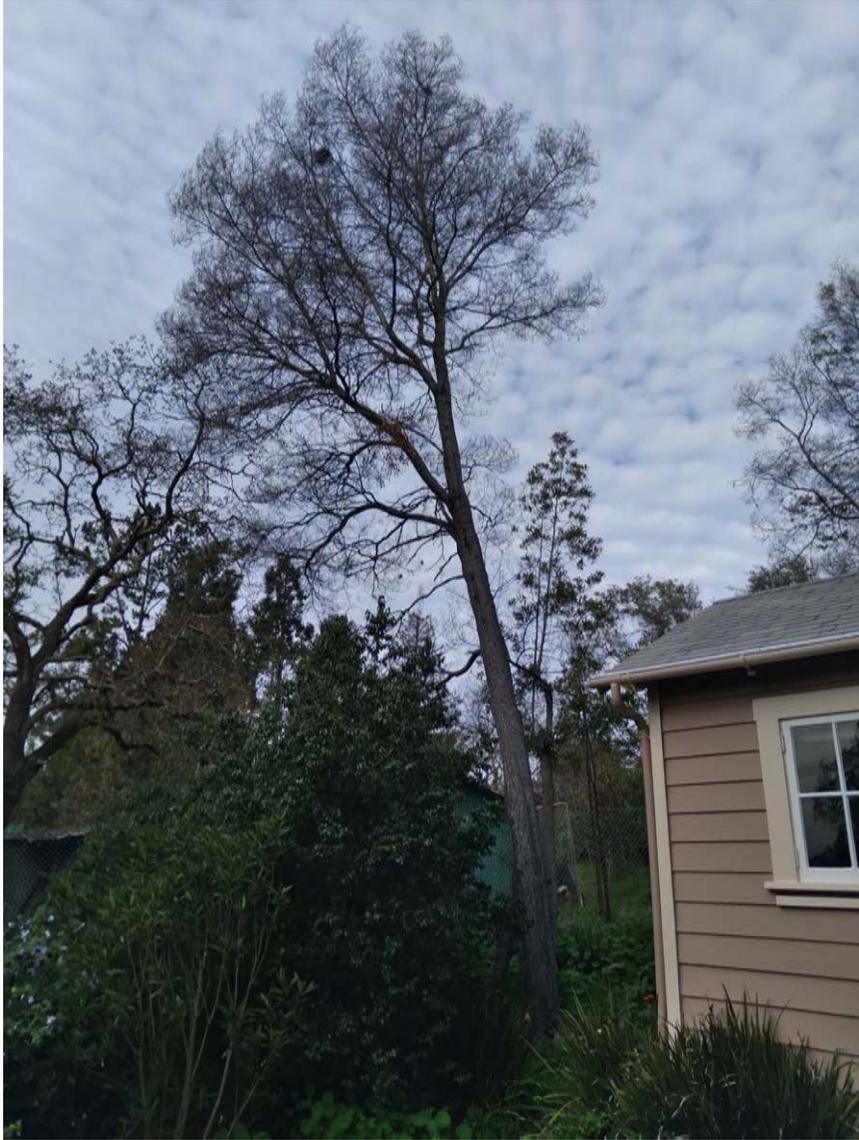
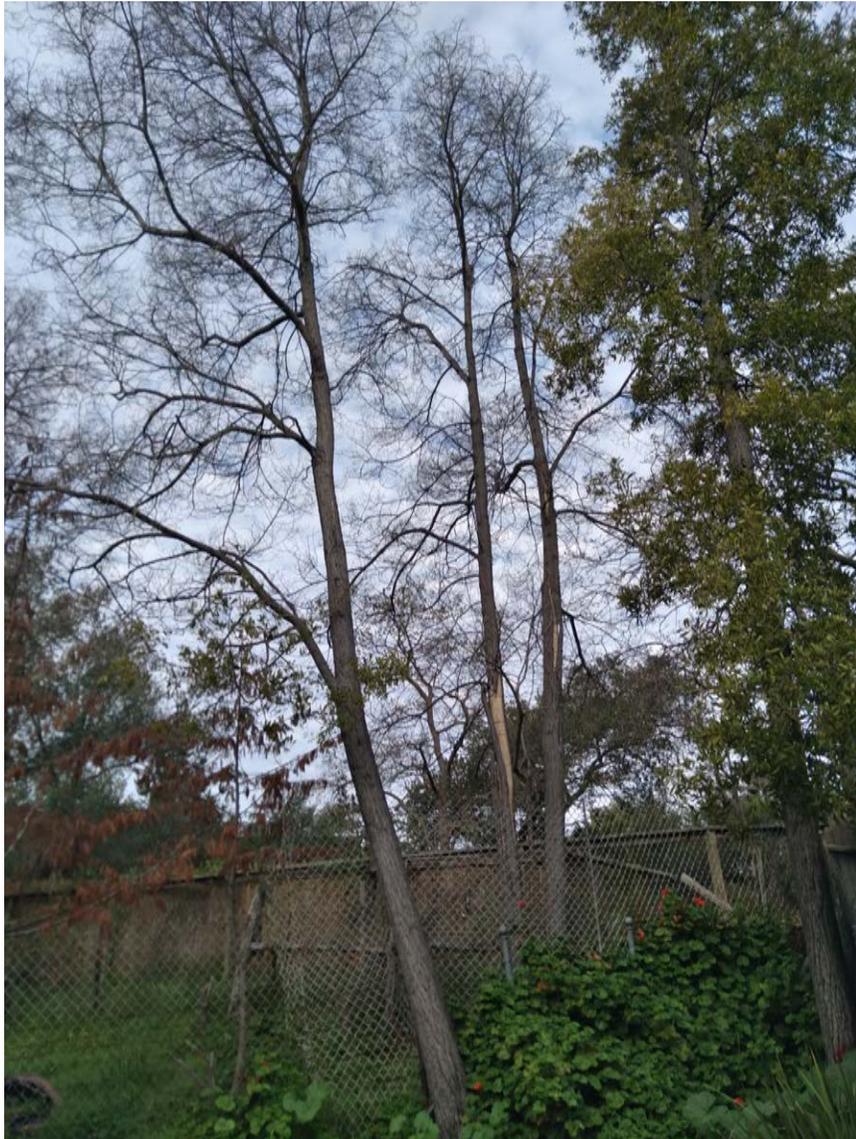
Trees #14, #15, and #17 are Black Acacias located along the left side and rear of the guest home at the left rear corner of the site. Overall, these trees have poor form, are in severe decline and should be considered hazards.

I recommend all three trees be removed.

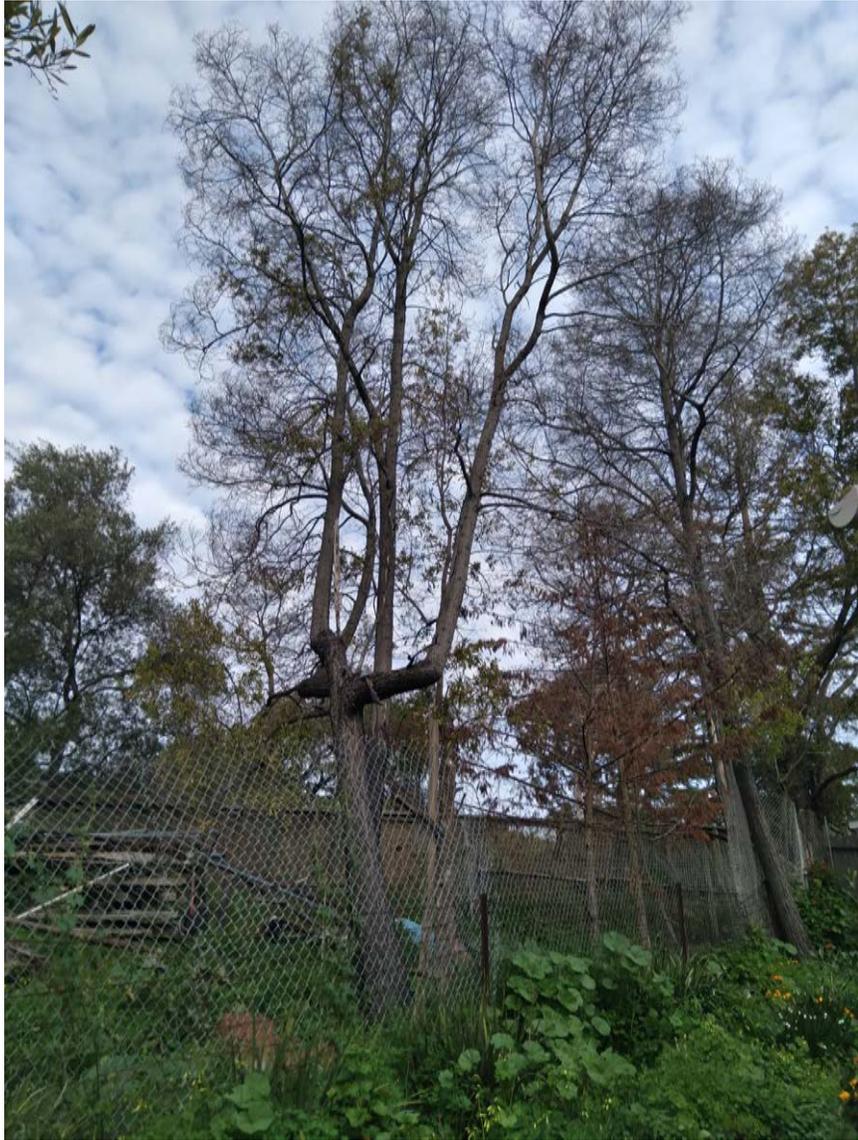
Tree #16

Trees #16 and #18 are located on the western neighboring property. These trees are almost completely dead and should be considered hazards.

I recommend talking with the neighboring property owner to discuss the health of these trees and possible removal in the near future.

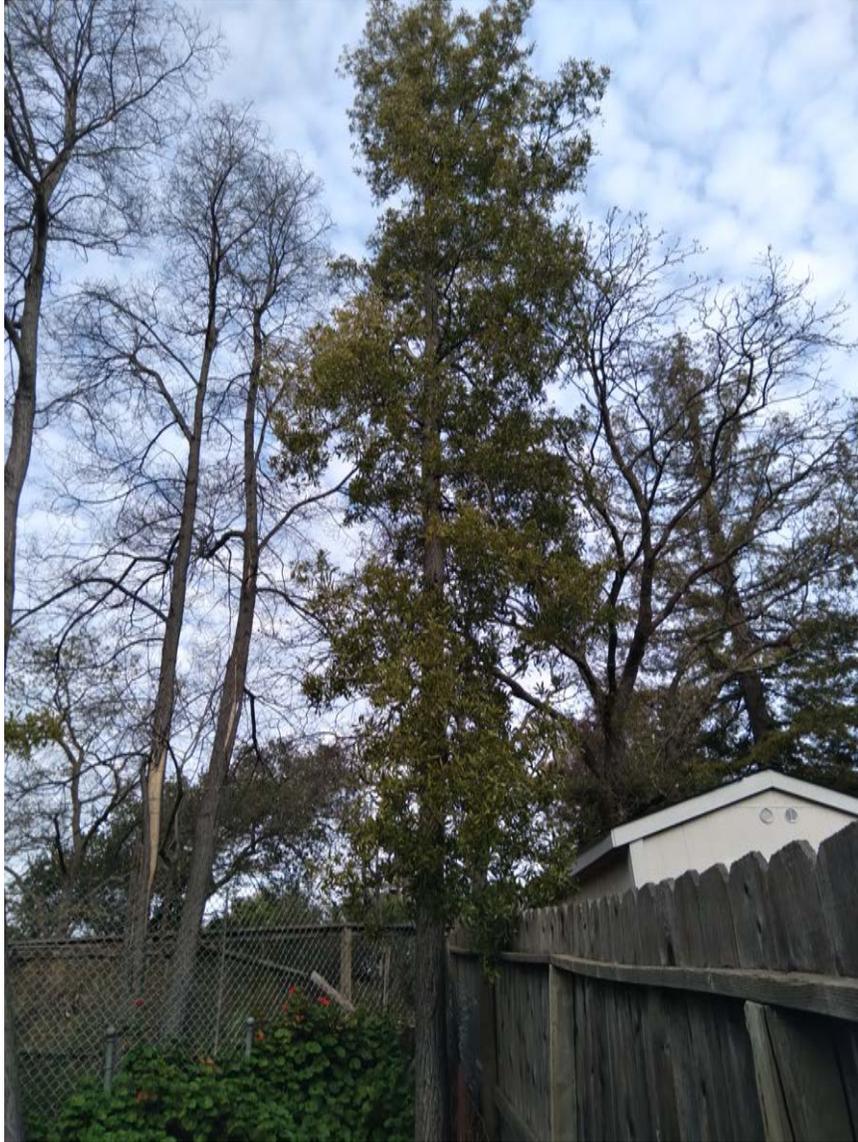
Tree #19 is a Black Acacia located along the left rear corner of the site. Soil and other organic material partially cover the root crown, a slight lean to the north. Overall, this tree has fair form, and good vigor.

This tree is located very near the property line fence, it has the potential to become very large and damage the fence in the future. I recommend this tree be removed prior to becoming a large problem.

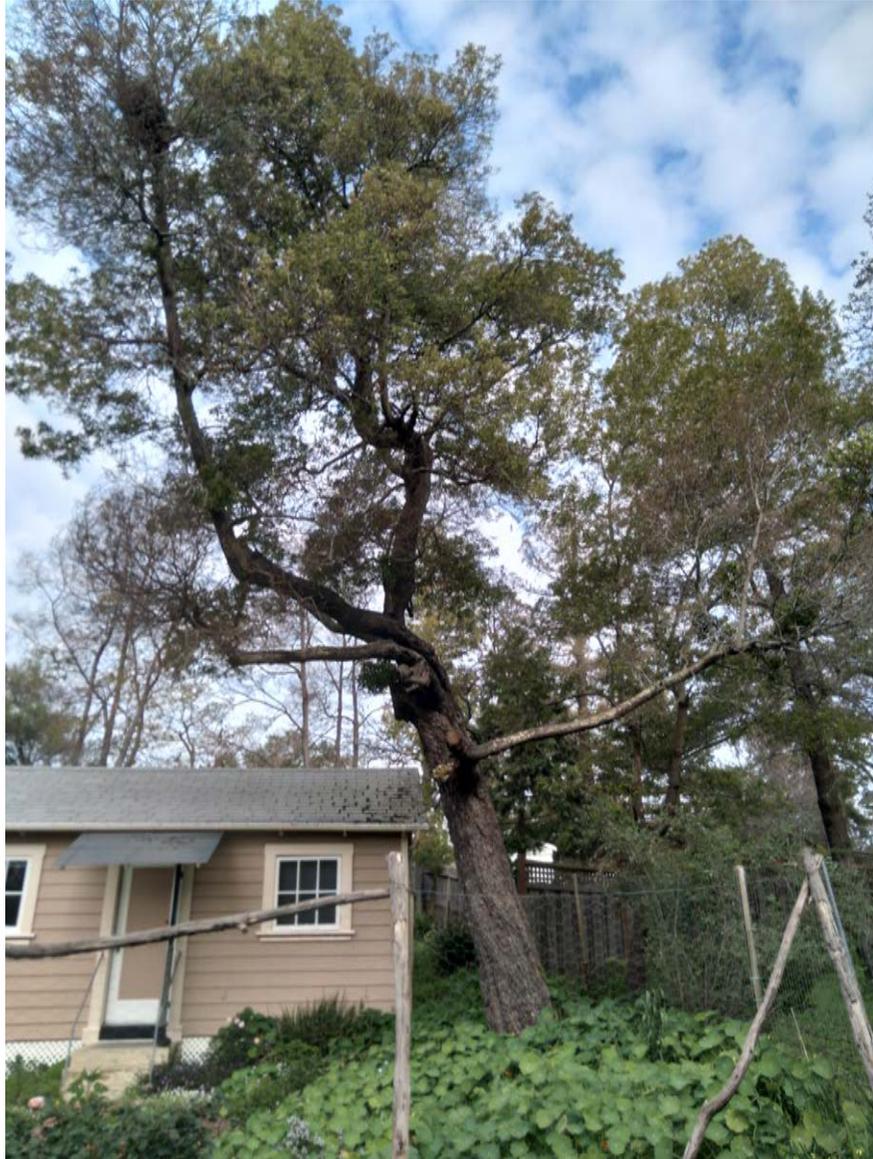
Tree #20 & #21

Tree #20 is a Black Acacia located near the right front corner of the guest home. Soil and other organic material substantially cover the root crown of this tree. It leans to the southwest over the walkway to the guest home, has a cavity at 4 feet on the southwest side of the trunk, a sulfur fungus mushroom is present at 10 feet, a codominant top at 15 feet, a moderate amount of interior deadwood. Overall, this tree has poor form, and vigor.

I believe this tree is in severe decline and poses a hazard to the inhabitants of the property. I recommend removal of this tree as soon as possible.

Tree #21 is a Black Acacia located along the northern neighboring property line on the neighboring property. This is a relatively small tree that leans to the north. Overall, this tree has fair vigor and form.

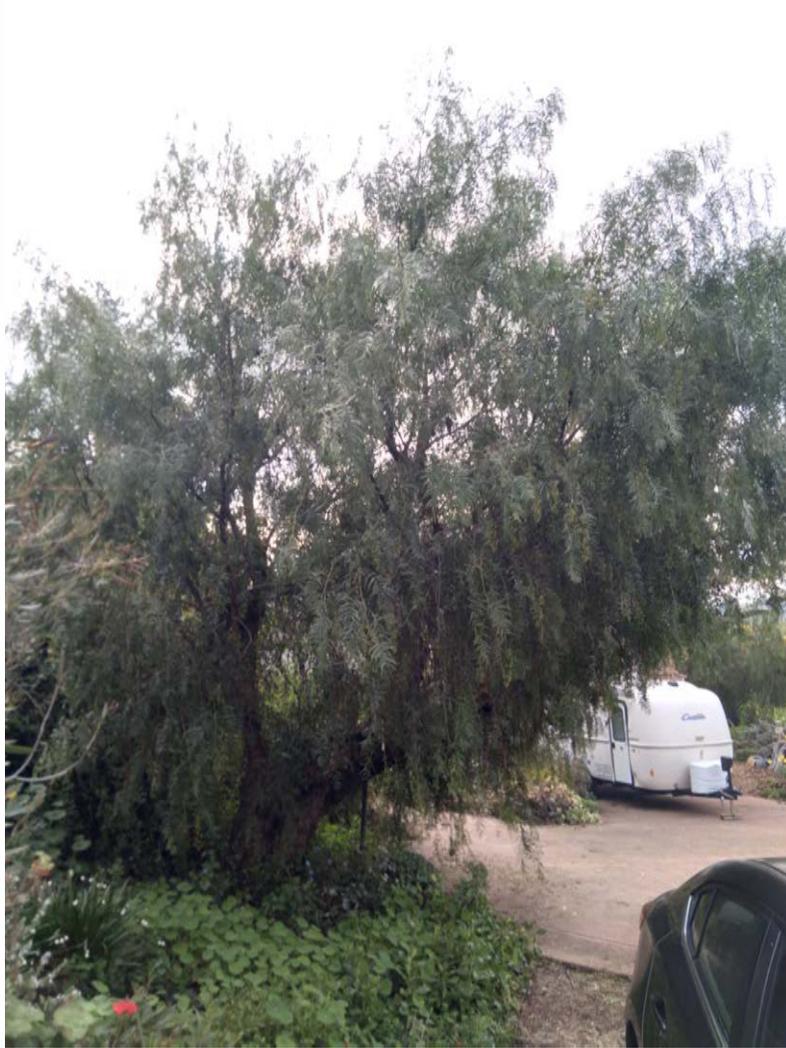
Tree #22 is a California Pepper located along the northern property line at the end of the driveway. Grass, soil, and other organic material cover the root crown. It has a support pipe on the southwest side of the canopy, sunscald on the upper side of the canopies, a three-stem attachment at 2 feet, a small amount of interior deadwood. Overall, this tree has good vigor and poor form.

Due to this tree's size, it does not pose a significant risk however, the lower trunk is structurally compromised. Without the support pipe I believe this tree would have already failed. I recommend, considering this tree for removal unless the area under and around this tree can be fenced off to limit access. Being located at the end of the driveway where vehicles are frequently used this tree may cause damage of injury. The best option may be removal of this tree.

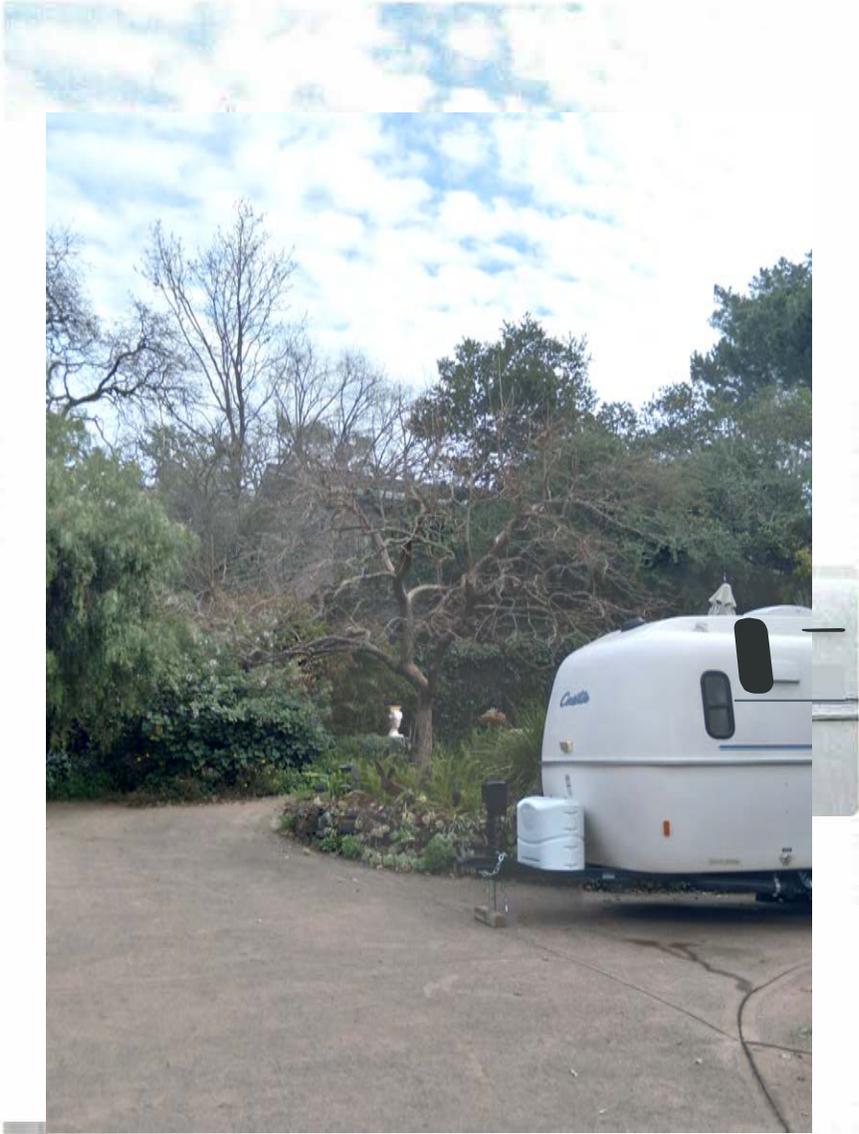
Tree #23 is a Persimmon located along the driveway on the left side of the main home. Soil and other organic material cover the root crown, it has a multi-stem top at 8 feet, and a slight lean to the southwest. Overall, this tree has fair vigor, fair form,

I recommend continuing with routine tree maintenance to keep the tree small and allow better access to harvest the fruit.

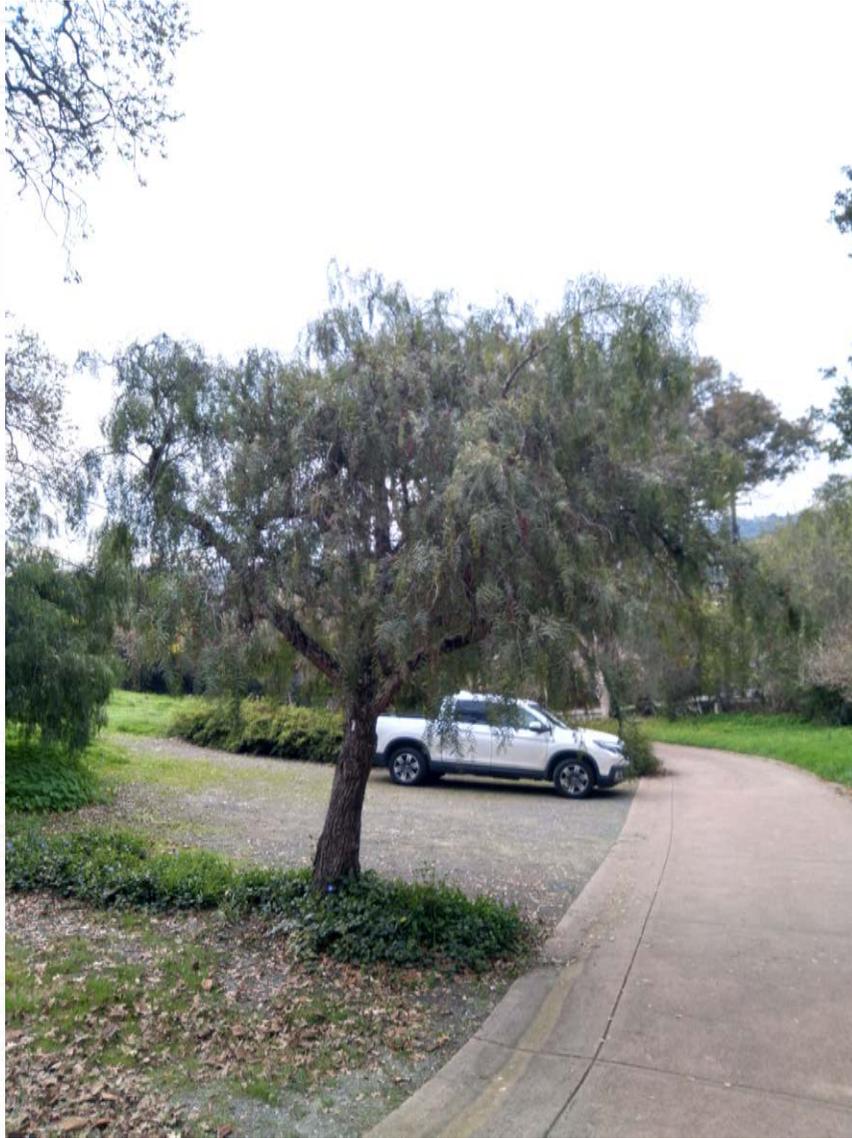
Tree #24 is a California Pepper located near the right side of the driveway nearest to the main home. It has a four-stem at 6 feet high, a moderate amount of interior deadwood, Overall, this tree has fair vigor, and form.

I recommend routine tree maintenance that should include routine tree maintenance to keep the canopy small and balanced.

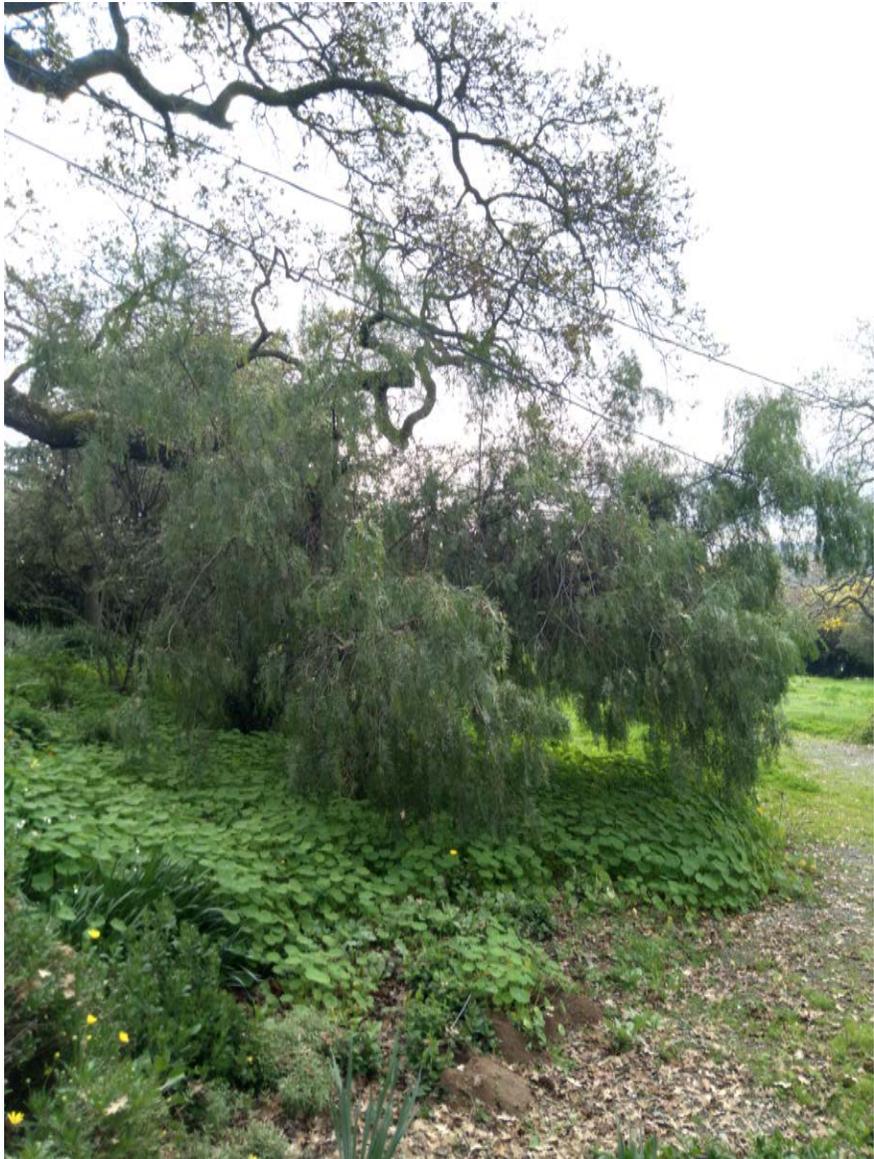
Tree #25 is a California Pepper located along the right side of the driveway towards the center of the property. Soil and other organic material cover the root crown. It has a two-stem attachment at 2 feet, leans to the southwest, has a moderate amount of interior deadwood. Overall, this tree has fair vigor and poor form.

I recommend routine tree maintenance that should include exposing the root crown, removal of the interior deadwood, and shaping the canopy to maintain a balanced form with reduced end weight.
