Mayne Tree Expert Company, Inc.

February 8, 2022

Mr. Paul Goswamy
890 Upland Rd.
Redwood City, CA 94062

RE: ARBORIST REPORT

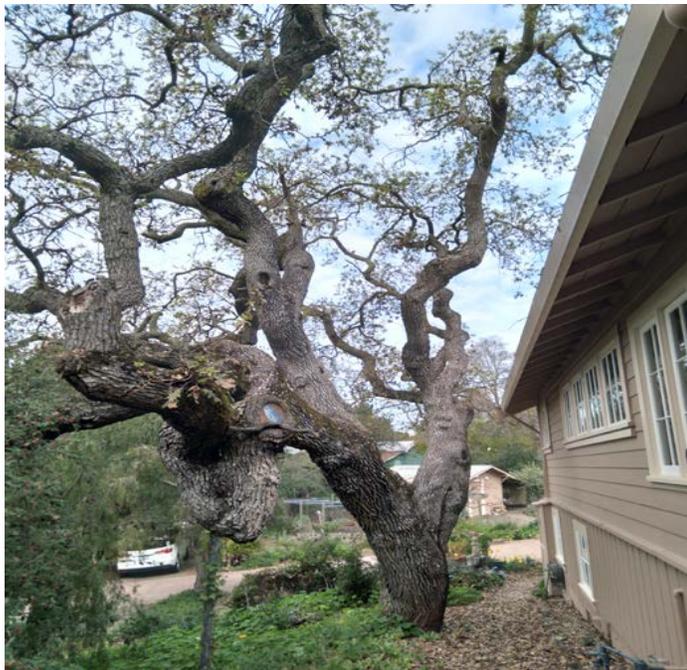
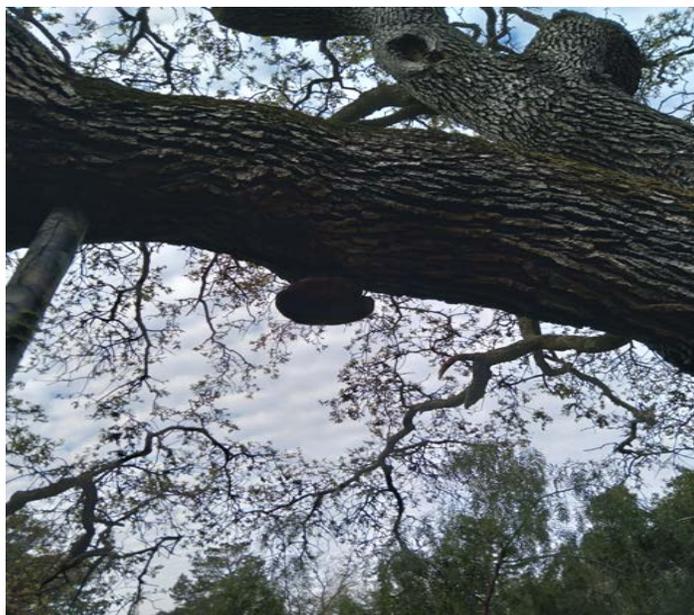
Tree #26 is a large Valley Oak located in front of the main home. Soil and other organic material substantially cover the root crown. It has a two-stem attachment at 5 feet, a bulbous hollow lower trunk with several screen covered cavities present around the lower trunk. There is a support pipe on the south side of the canopy and a 8 inch diameter mushroom from a heart rot fungus present on the underside of the southern branch. There is an old cable present in the upper canopy, heavy lateral limbs. Overall, this tree has fair vigor, and poor form.

This is an old tree located in a frequently used area. The lower trunk is hollow and there is an unknown amount of internal decay. To gather more information on the integrity of the lower trunk I recommend an additional more thorough exam of this tree take place. Without supporting evidence this tree is structurally sound, I believe this tree has a high potential to fail and poses an unacceptable risk to the occupants of the home. I recommend removal of this tree in the near future.

If it is deemed an acceptable risk and the tree is to remain, I recommend routine tree maintenance that should include exposing the root crown, end weight reduction, and inspecting the support cable in the upper canopy. This tree has a substantial amount of internal decay that may compromise the structural integrity.

Special inspections for **trees #3 and #26** should take place to confirm the structural integrity of the lower trunks and better decide what is an acceptable risk for the homeowner.

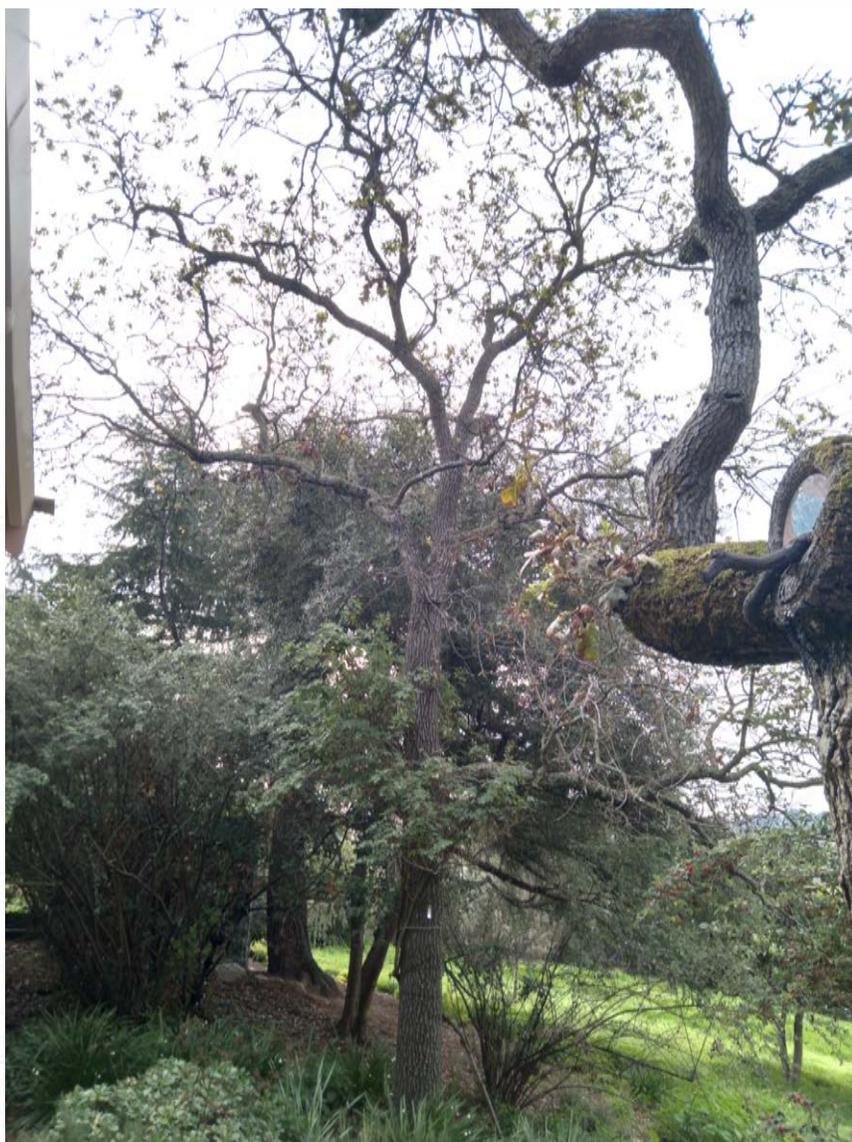
Tree #27 is a Valley oak located along near the right front corner of the main home. Soil and other organic material partially cover the root crown, it has a Rose vine attached to the trunk, a codominant top at 15 feet, and most of the canopy growth is away from the northeast. Overall, this tree has good vigor and fair form.

I recommend routine tree maintenance that should include exposing the root crown, removal of the vine from the trunk, deadwood from the canopy, and shaping the tree to create a future balanced canopy form.

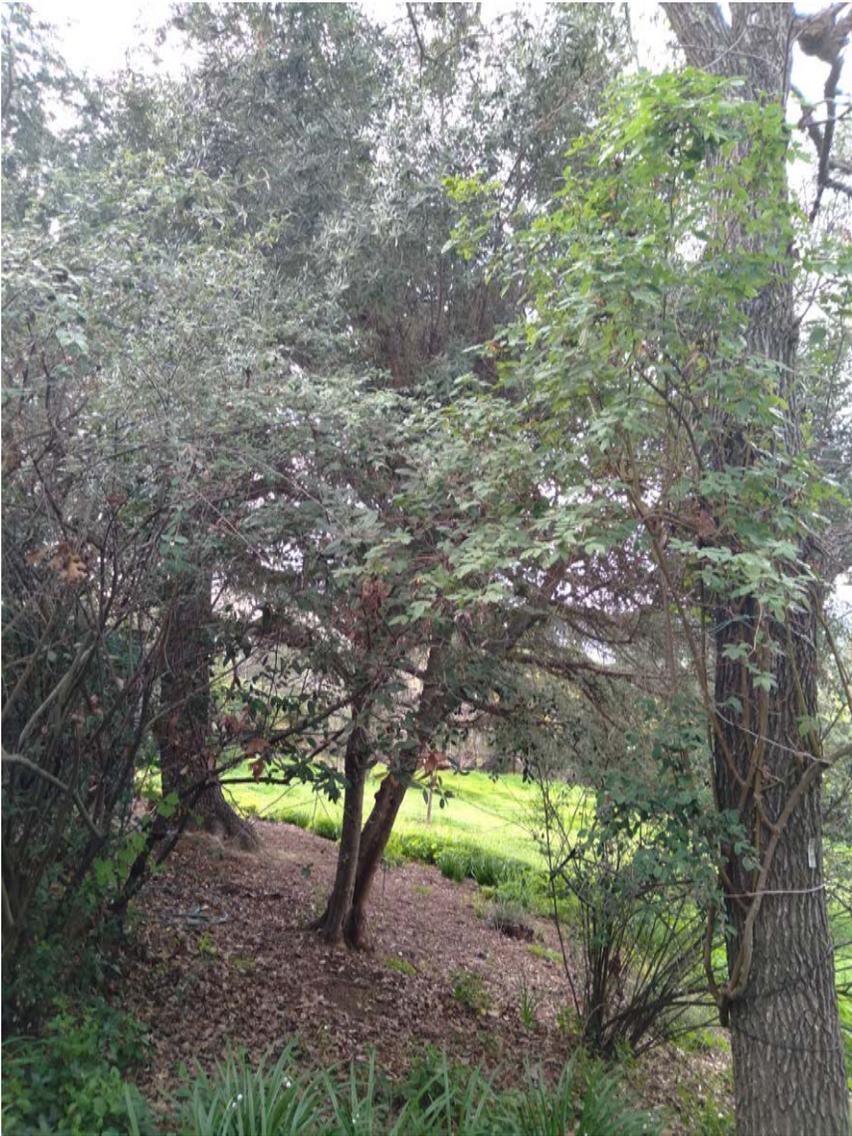
Tree #28 is an Olive located near the center of the property. This tree has a codominant attachment with included bark at 2 feet, a minor amount of interior deadwood, it leans to the northwest. Overall, this tree has good vigor and poor form.

I recommend routine tree maintenance that should include shaping the canopy and removal of the interior deadwood.

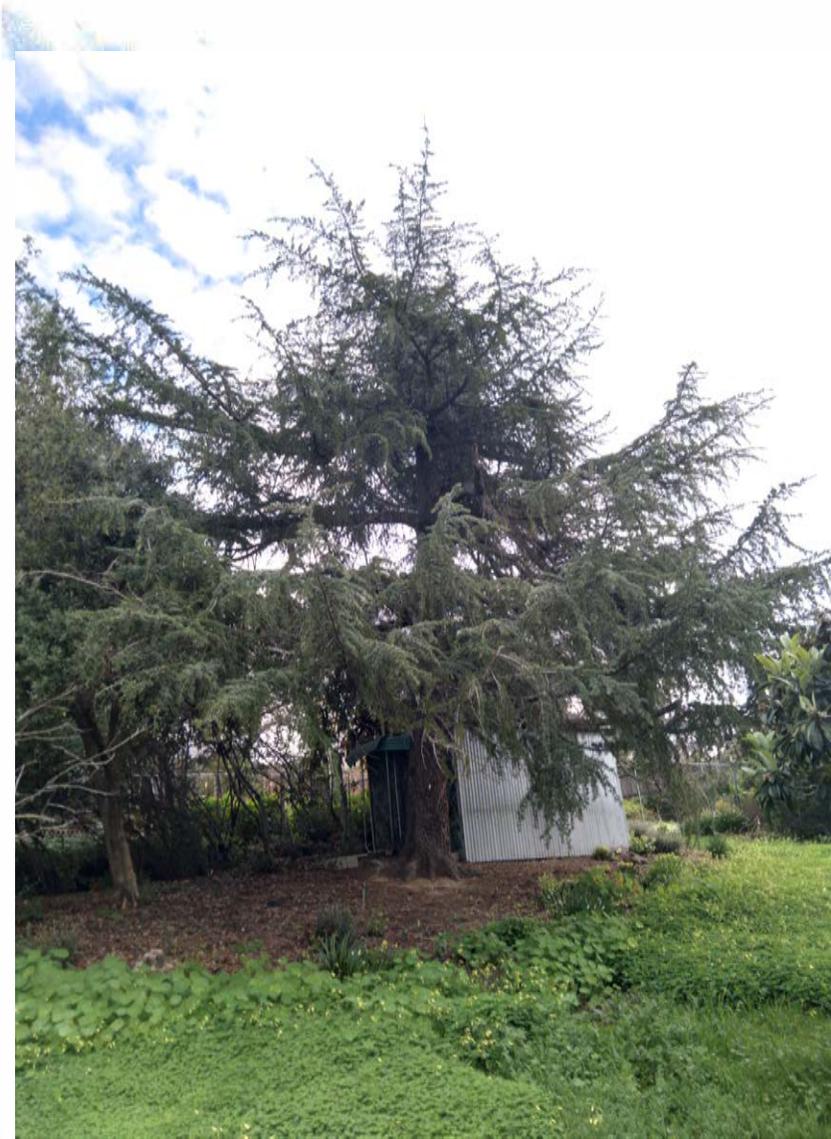
Tree #29 is a Deodar Cedar located near the center of the property. This tree has an abundance of interior deadwood, heavy lateral limbs and was topped at 25 feet. There are several sprouts forming a new top from the old topping cut.

I recommend routine tree maintenance that should include reshaping the tree to promote a better-balanced form. This includes end weight reduction, structural canopy thinning and removal of the interior deadwood.

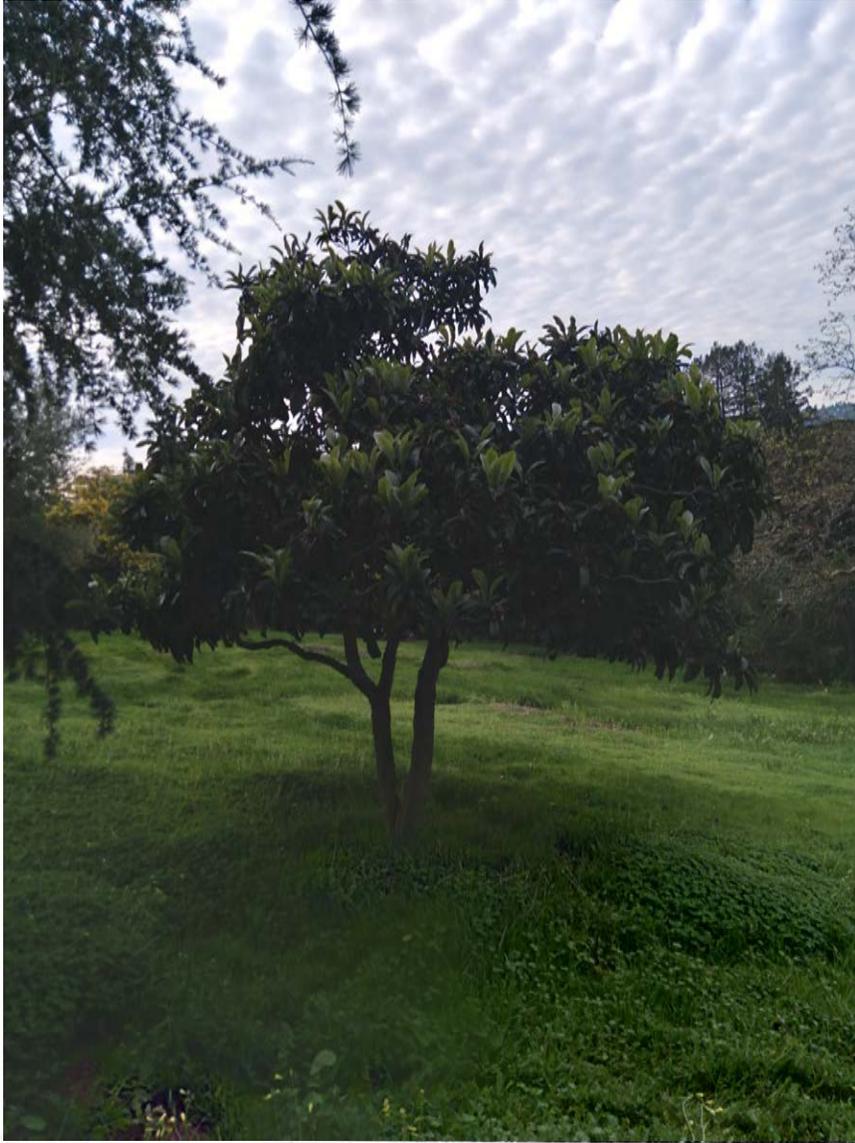
Tree #30 is a Loquat located on the north side of the Deodar Cedar canopy. Soil and other organic material cover the root crown, is has a codominant attachment with included bark at 1 foot, decay at 5 feet, fair vigor, and poor form. This tree has very poor form with a decayed trunk supporting a vigorous heavy canopy.

I recommend removal of this tree due to the poor form and likely failure of the main stem.

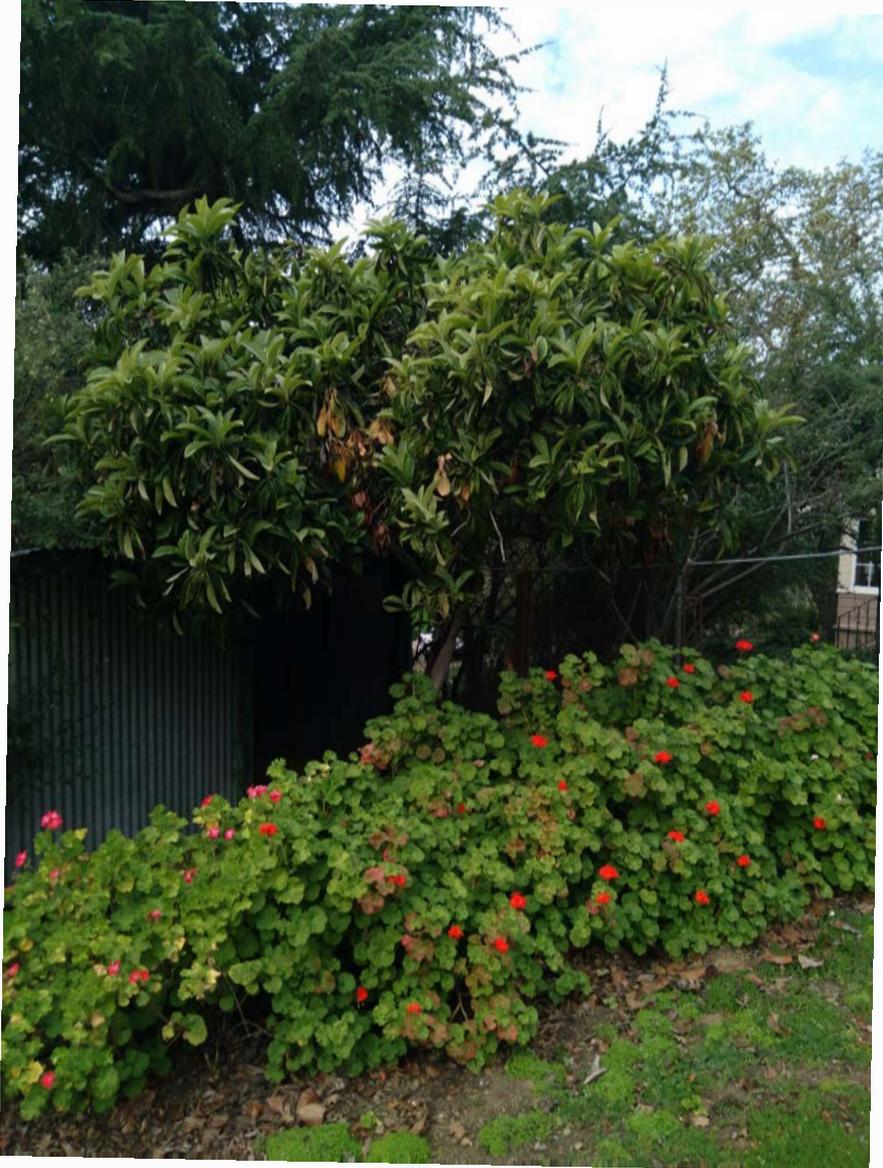
Tree #31 is a Loquat located near the center of the property. Soil and other organic material cover the root crown. It has decay on the lower trunk at 3 feet a codominant attachment with included bark at 5 feet, a healthy vigorous canopy with poor form.

I recommend routine tree maintenance that should include exposing the root crown and shaping the canopy to maintain a balanced form.

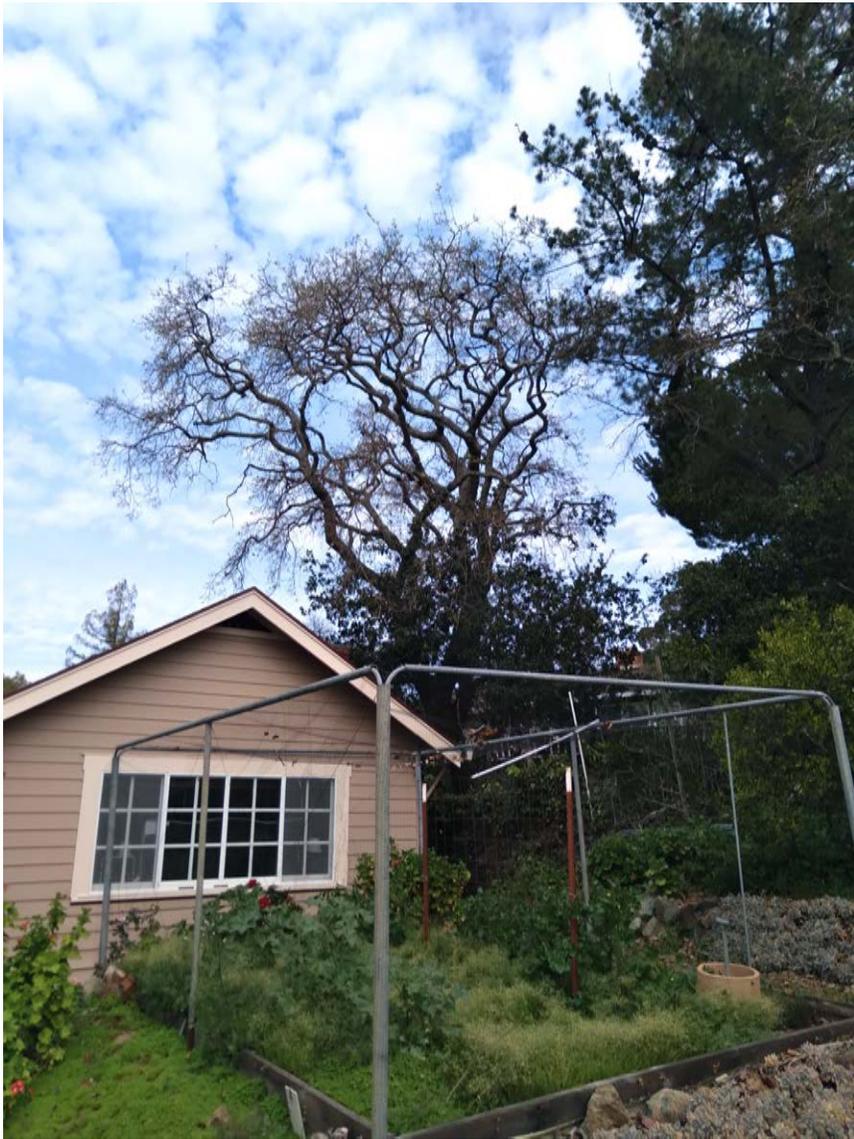
Tree #32 is a valley oak located on the northern neighboring property above the property line fence by about 10 feet. I estimated the trunk diameter due to the limited access; it has a two-stem attachment at 10 feet, a moderate amount of interior deadwood. Overall, this tree has good vigor and fair form.

I recommend routine tree maintenance that should include side pruning the upper canopy to reduce the growth over the property line into the client's property.

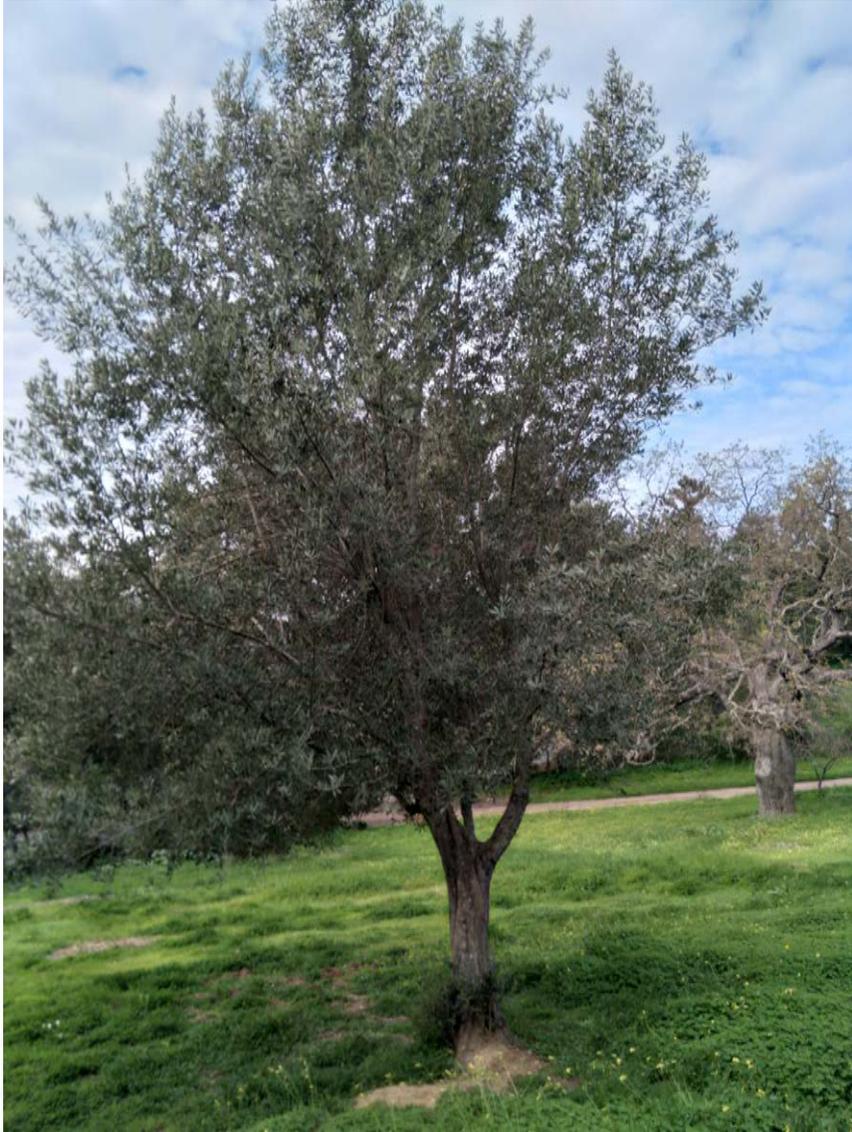
Tree #34 is an Olive tree located on the right center portion of the property. Soil and other organic material cover the root crown. It has a codominant attachment with included bark at 3 feet, leans to the west, has a moderate amount of interior deadwood, Overall, this tree has fair vigor, and poor form.

I recommend routine tree maintenance that should include exposing the root crown, removal of the interior deadwood and shaping the canopy to promote a balanced tree form.

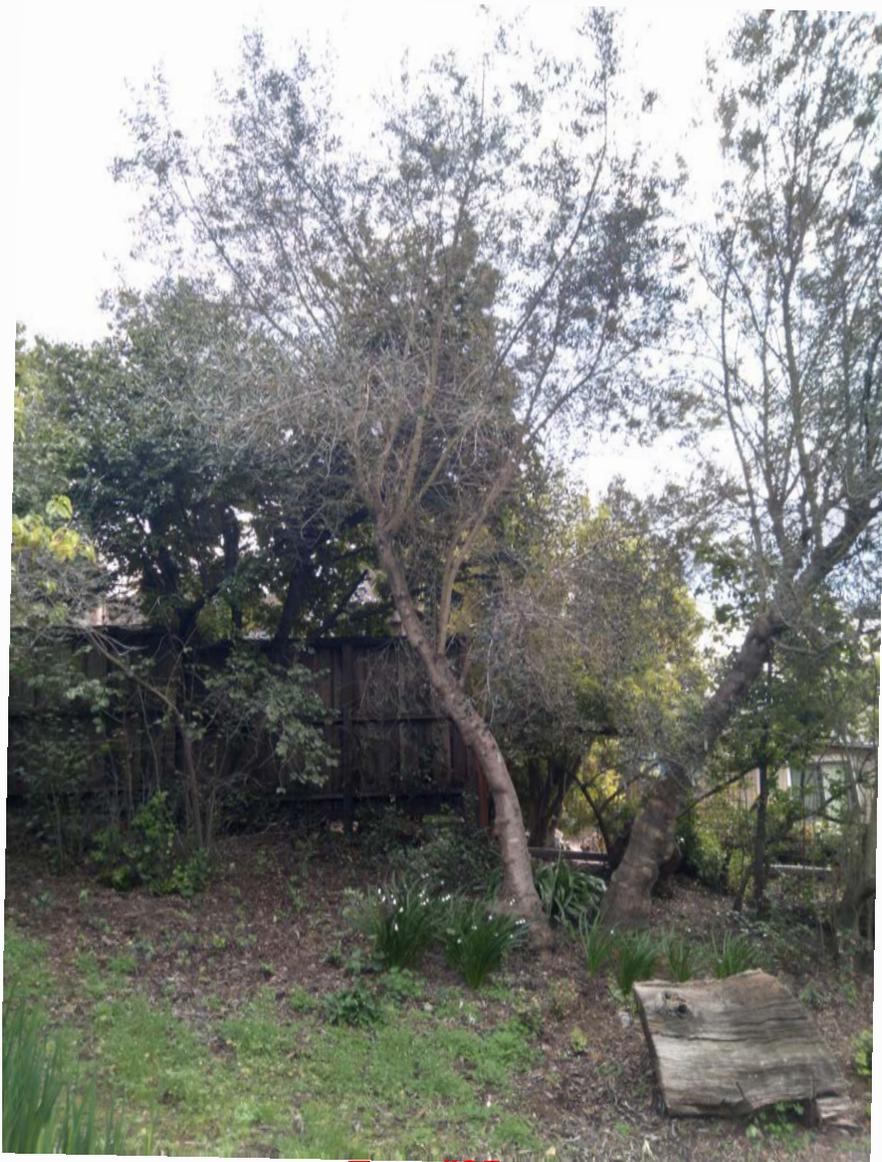
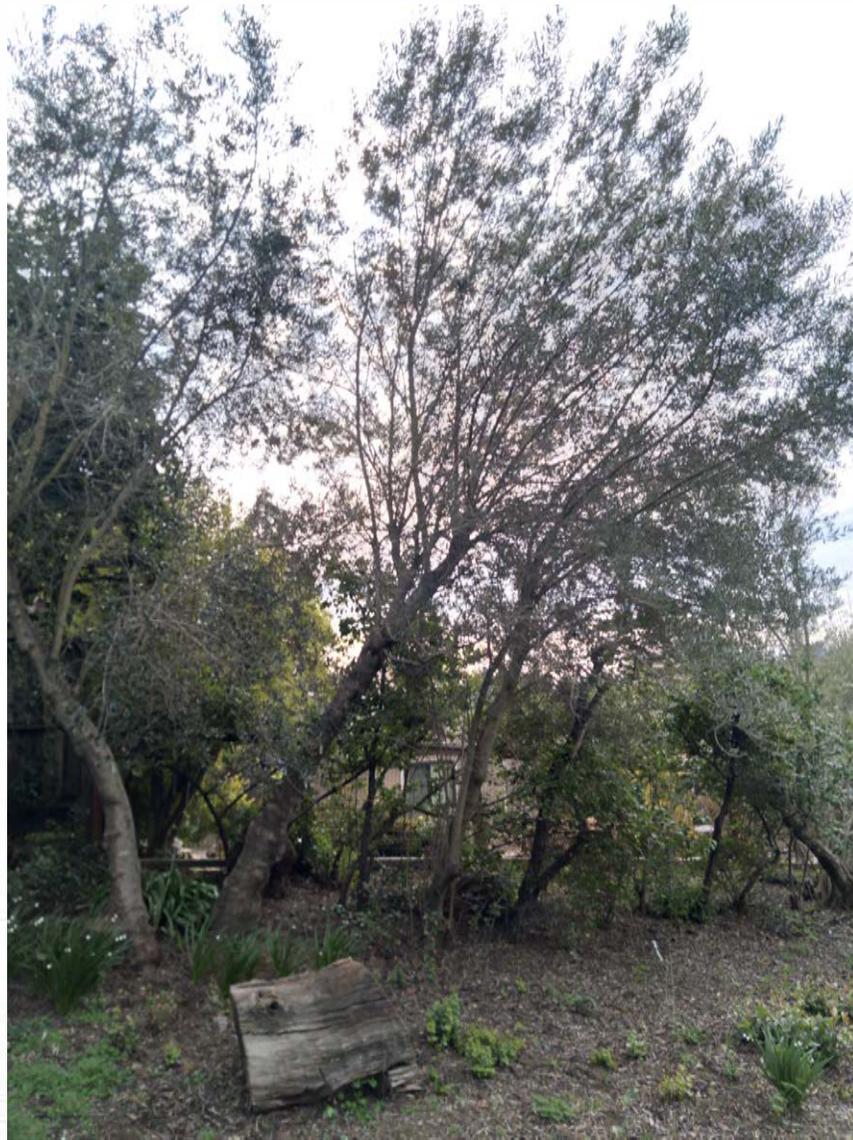
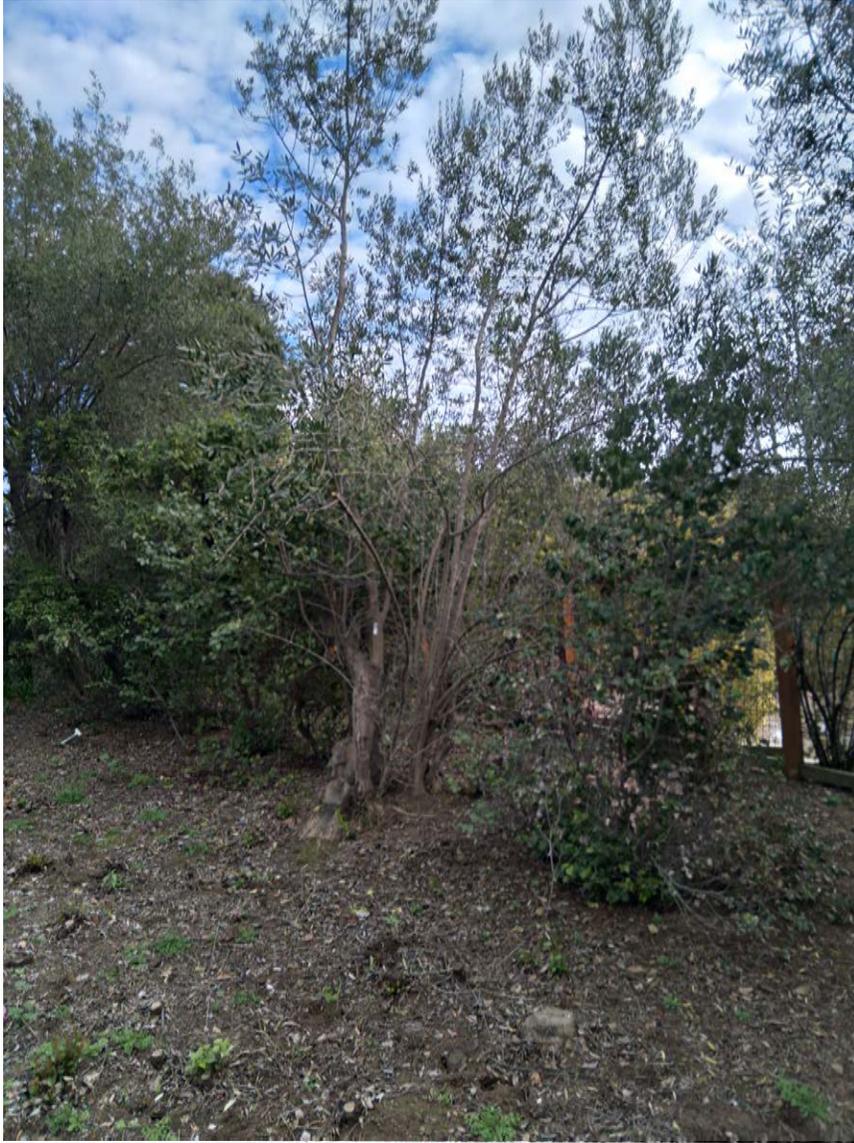
Trees #35, #36 and 37 are Olives located along the eastern property line. These trees have fair vigor and poor form. They provide some screening along the property line, several sprouts at their bases and moderate interior deadwood.

I recommend routine tree maintenance that should include shaping the canopies and removal of the interior deadwood.

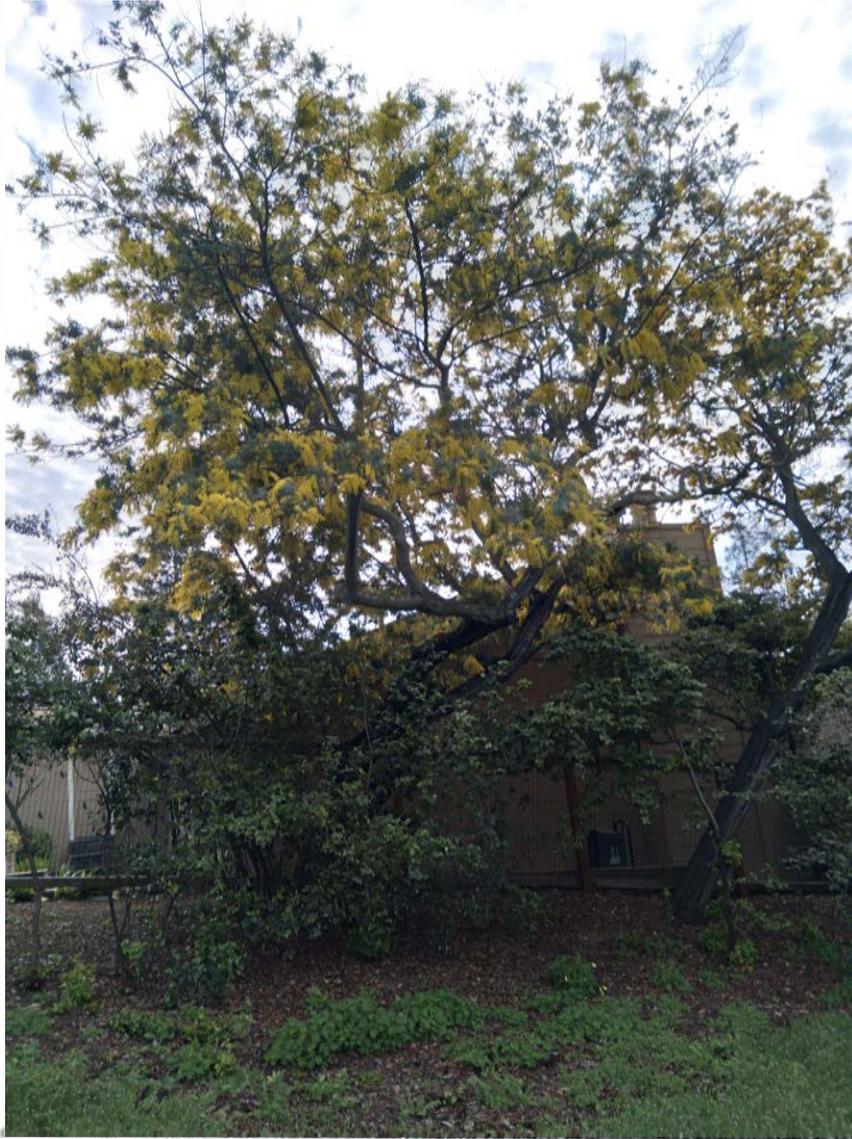
Tree #38 is a Baileyana Acacia located along the eastern property line. There is a significant amount of interior decay in the lower trunk, a significant lean to the southwest, heavy lateral limbs and included bark between many of the limb attachments. I believe this tree is structurally compromised and has a high potential to fail in the future.

I recommend removal of this tree due to its poor form and compromised structure.

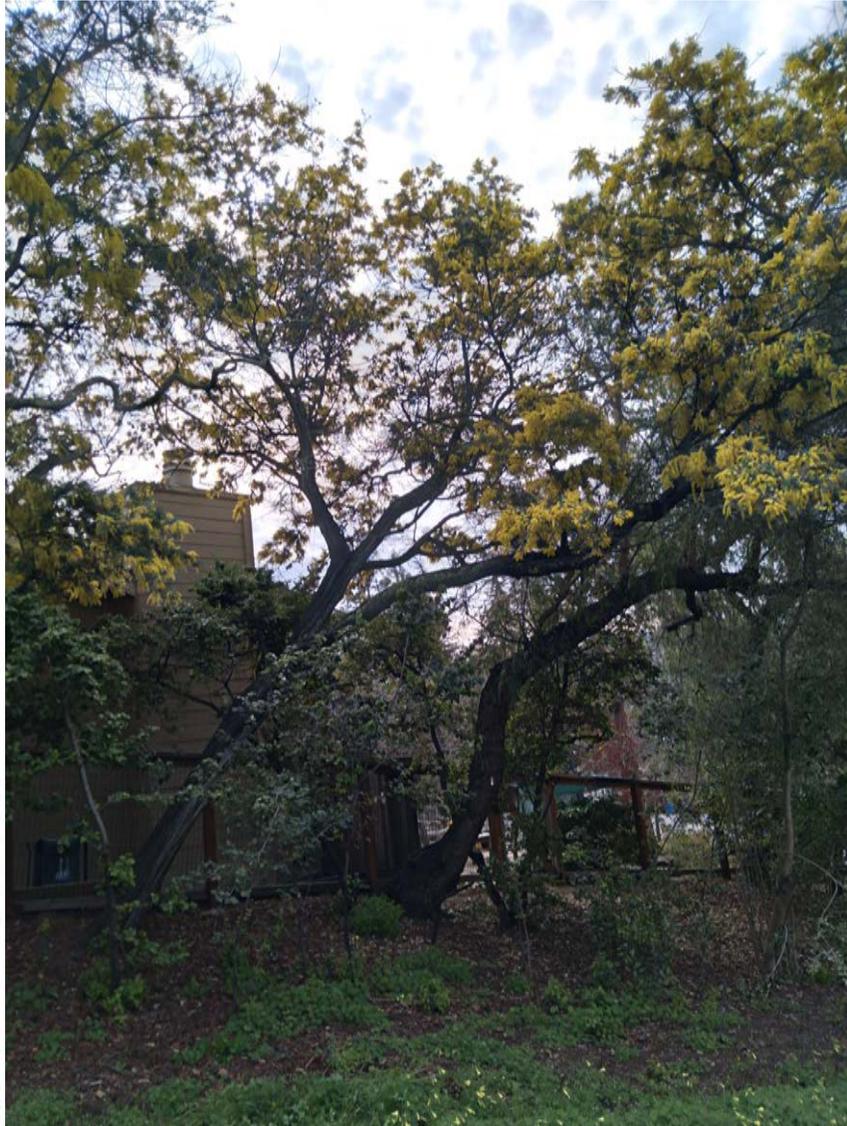
Tree #39 is a Baileyana Acacia located along the eastern property line. The whole tree leans significantly to the southwest, it has an upwelling in the rootzone opposite the trees lean, an abundance of interior deadwood, heavy lateral limbs. Overall, this tree has poor form and fair vigor.

I recommend removal of this tree due to the poor form and high likelihood of a failure.

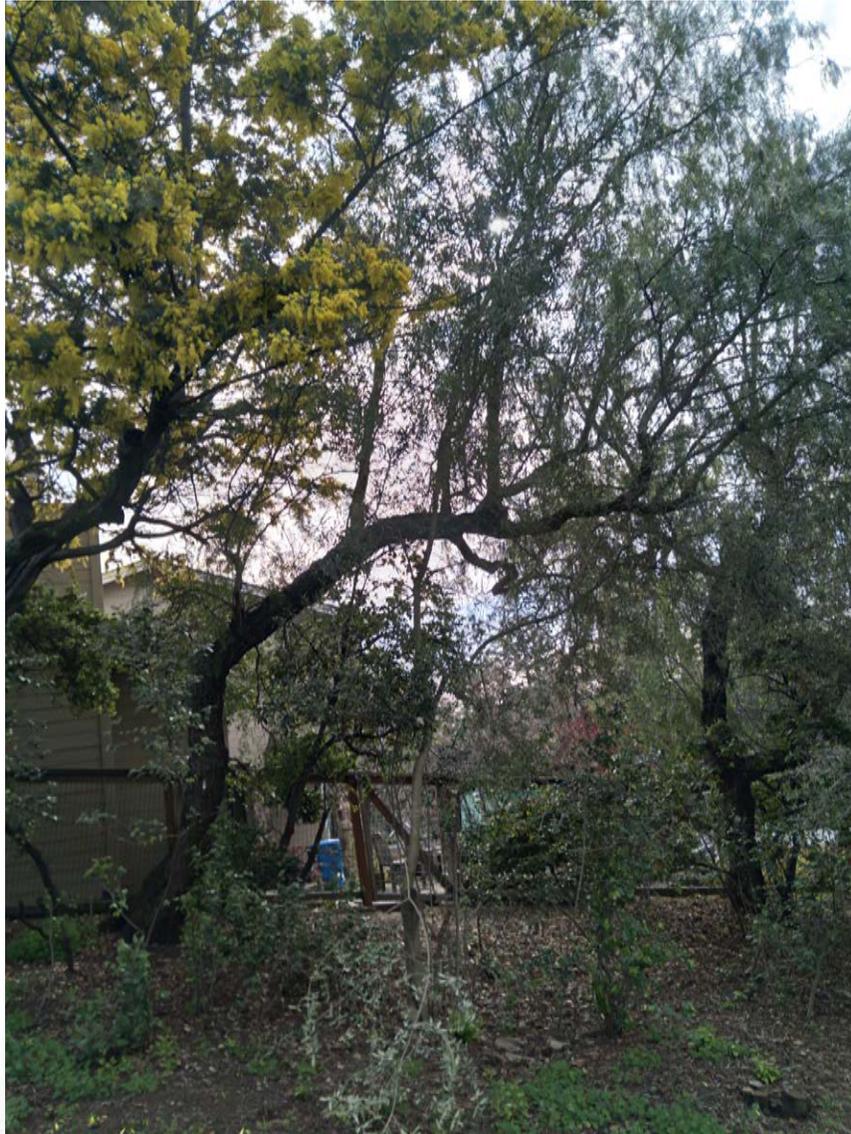
Tree #40 is a California Pepper located along the eastern property line. It has a cavity on the north side of the trees base, a significant lean to the southwest, heavy lateral limbs, a moderate amount of interior deadwood, a stag headed crown. Overall, this tree has poor form, and fair vigor.

I recommend routine tree maintenance that should include removal of the interior deadwood, shaping the canopy and inspecting the extent of decay at the base.

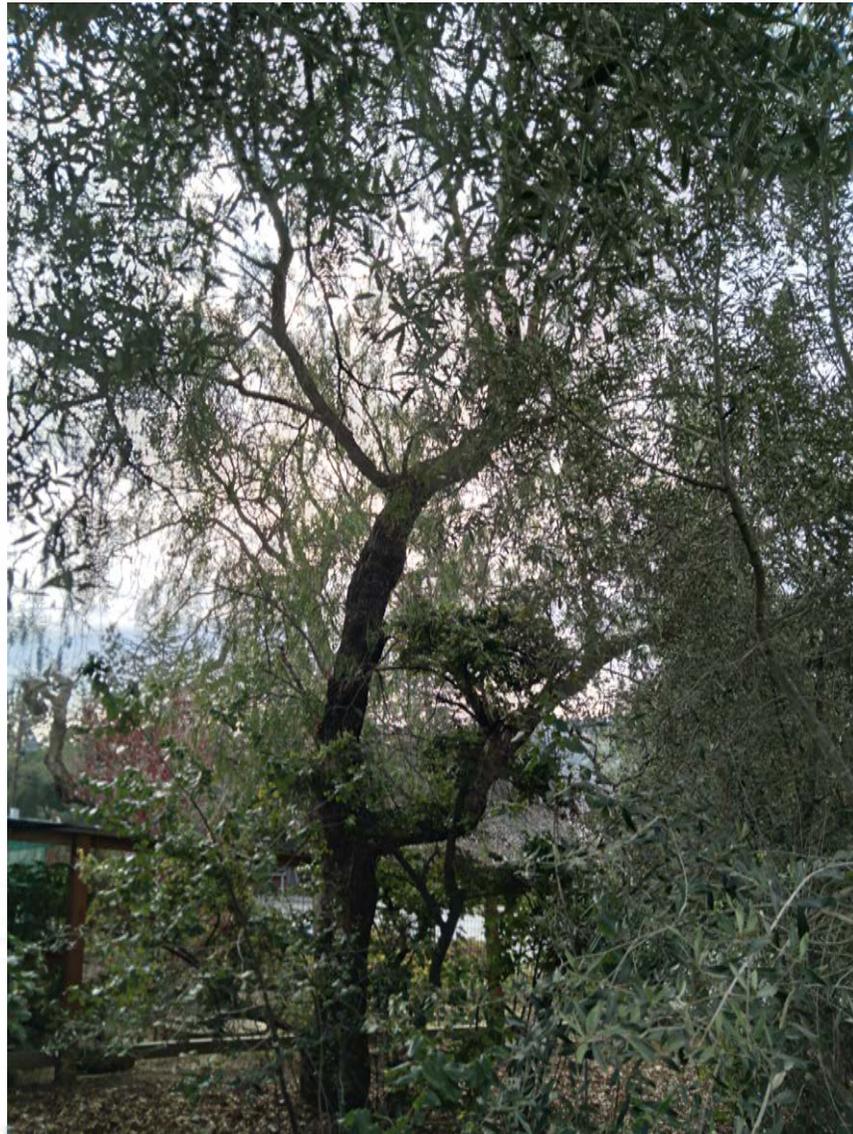
Tree #41 is a California Pepper located near the front right corner of the site. Soil and other organic material cover the root crown, it leans to the southwest, has a moderate amount of interior deadwood, a multi-stem top at 8 feet high, good vigor and fair form.

I recommend routine tree maintenance that should include shaping the canopy and removal of the interior deadwood.

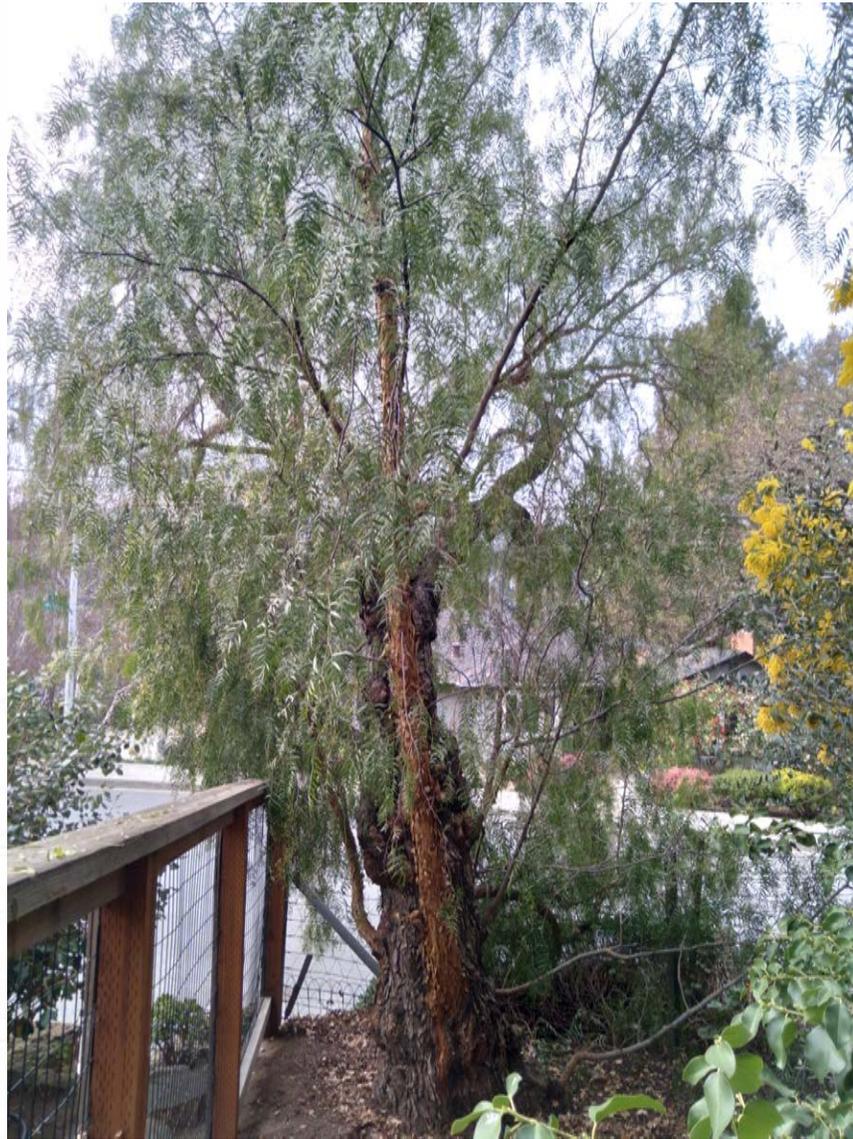
Tree #42 is a California Pepper located at the right front corner of the property. Soil and other organic material cover the root crown, it has a significant lean to the southwest over the street, a two-stem top at 10 feet. Overall, this tree has fair vigor, and poor form.

I recommend routine tree maintenance that should include exposing the root crown, shaping the canopy, and removal of the interior deadwood.

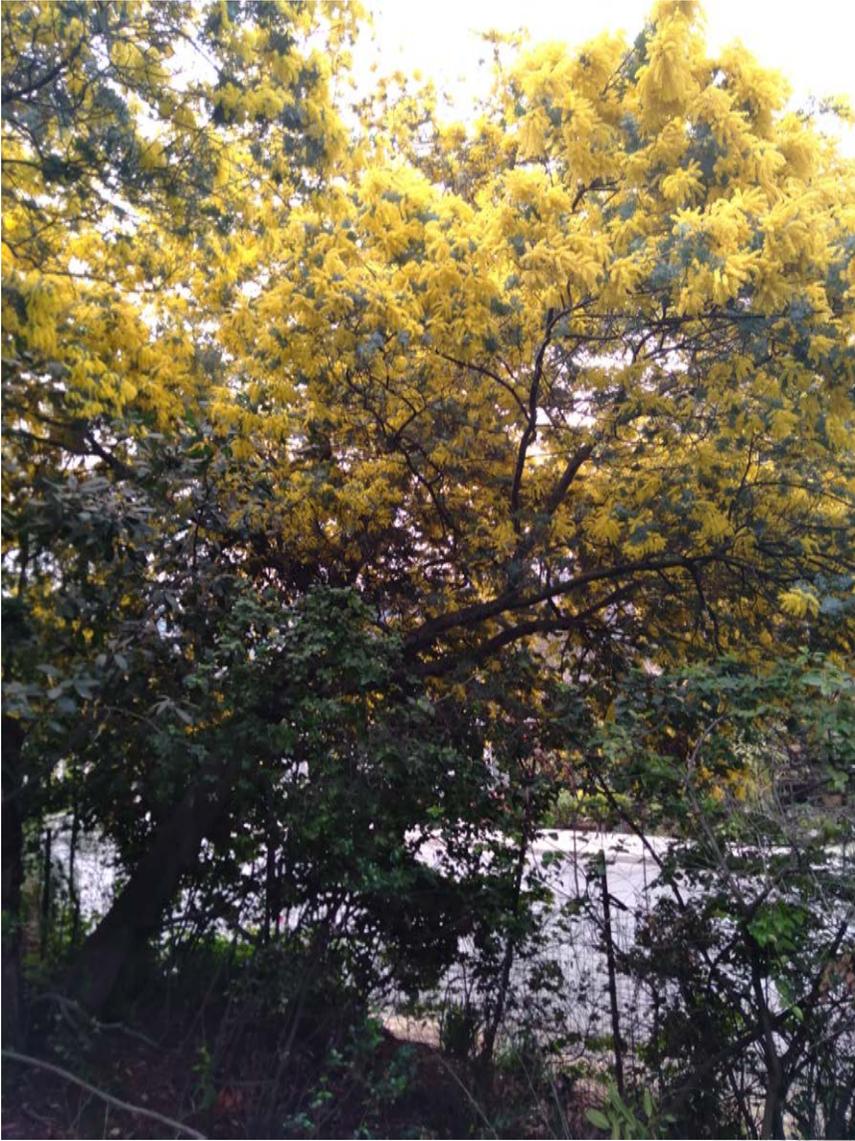
Tree #43 is a Baileyana Acacia located along the right front corner of the site by the street. It leans significantly to the southwest over the street, has a moderate amount of interior deadwood, heavy lateral limbs. Overall, this tree has good vigor, and poor form.

I recommend routine tree maintenance that should include end weight reduction over the street to promote a more vertical growth form, and removal of the interior deadwood.

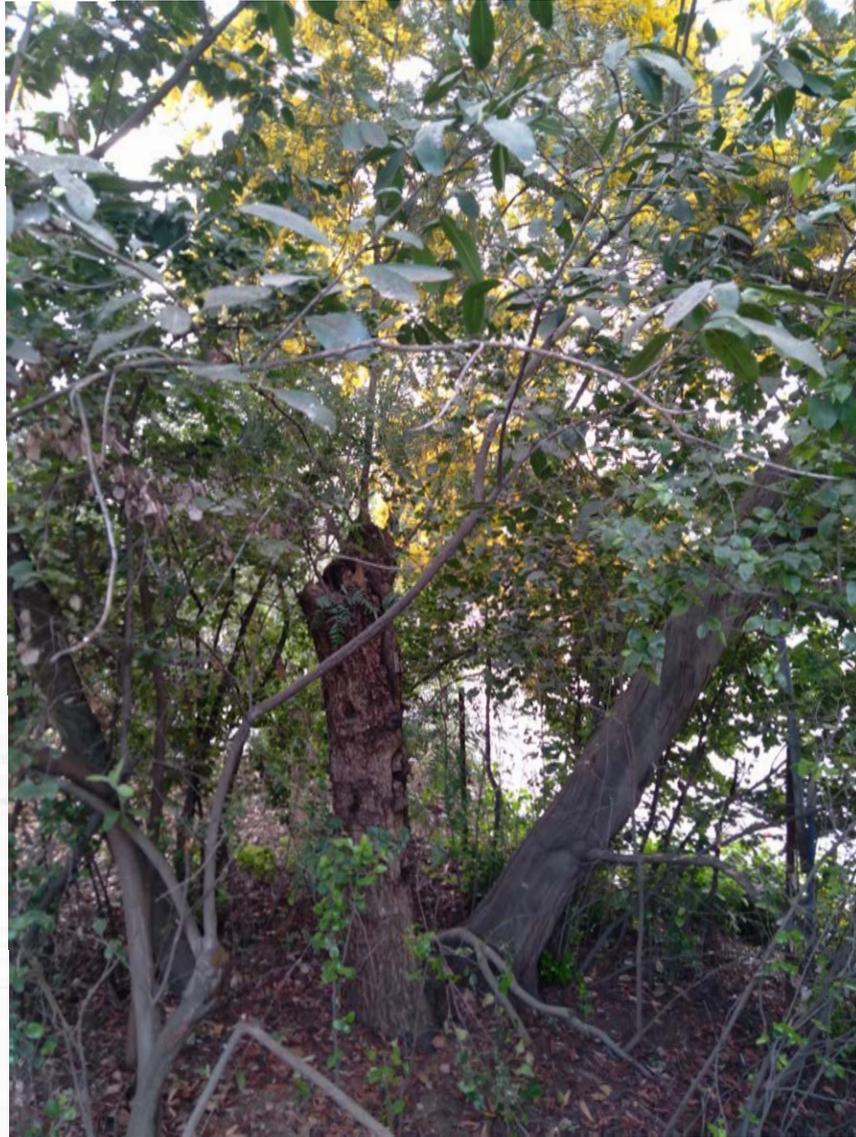
Tree #44

Tre #44 is a California Pepper located along the front right side of the property. This is mainly a trunk with several small sprouts. It was topped at 10 feet, has limited growth and decay at the old topping cut.

I recommend removal of this tree.

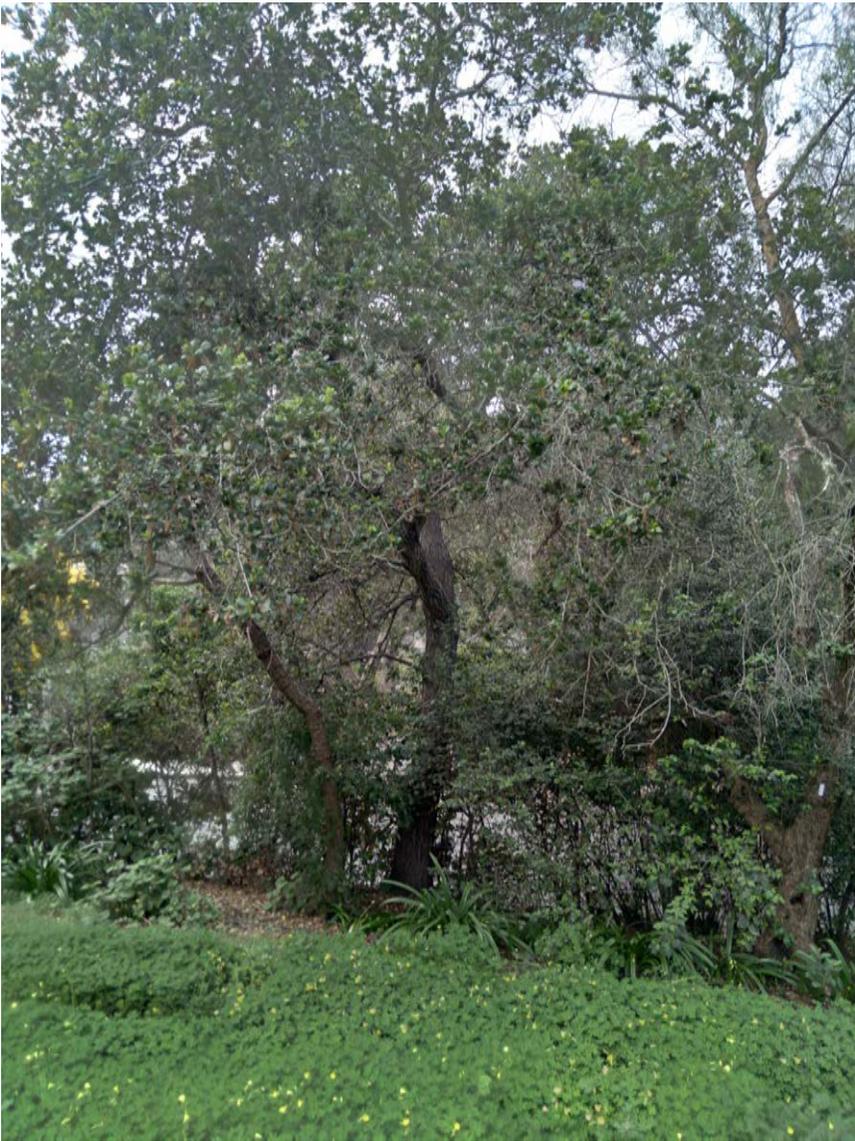
Tree #45 is a Coast Live Oak located along the front of the site. Soil and other organic material partially cover the root crown. It has a moderate amount of interior deadwood, heavy lateral limbs. Overall, this tree has fair vigor, and form.

I recommend routine tree maintenance that should include exposing the root crown, removal of the interior deadwood, and shaping the canopy to promote a better form.

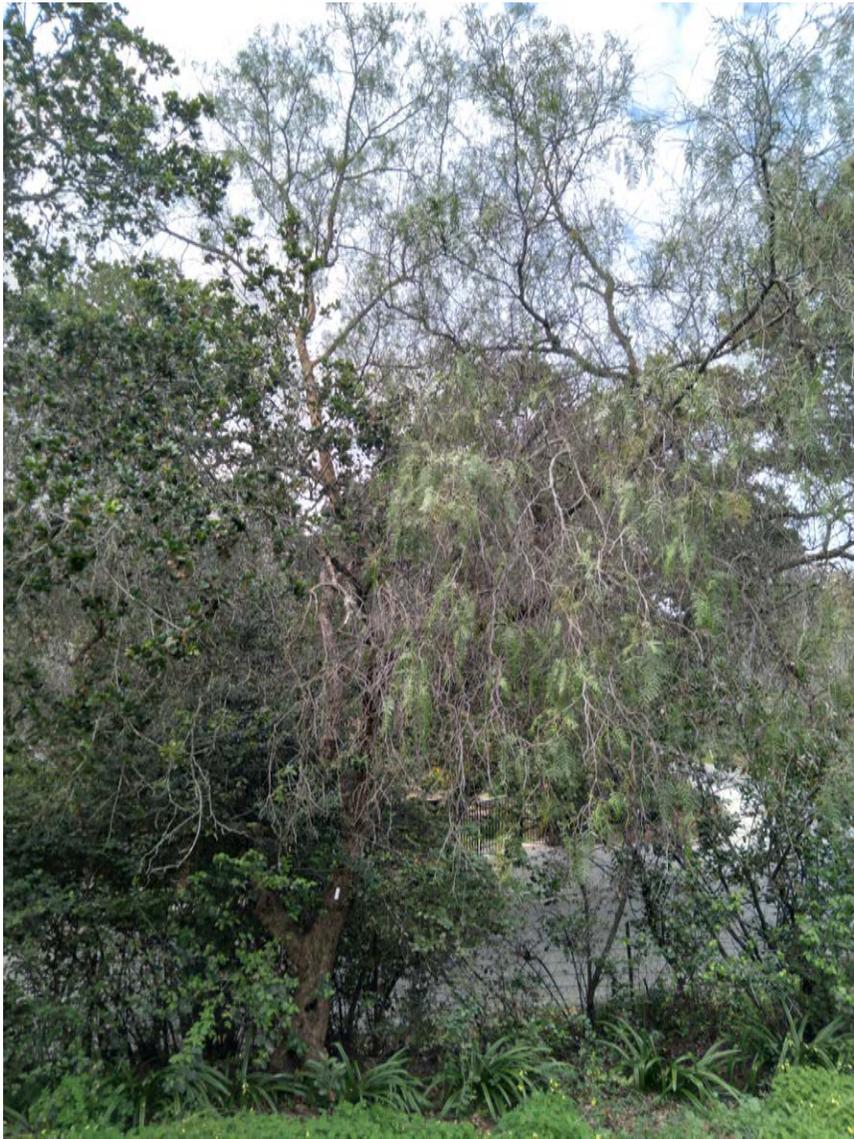
Tree #46 is a California Pepper located along the front of the site. Soil and other organic material cover the root crown, it has cavities on the east side of the base, a thinning upper canopy and appears to be mostly dead.

I recommend removal of this tree as it is in decline and almost dead.
