Mayne Tree Expert Company, Inc.

February 8, 2022

Mr. Paul Goswamy
890 Upland Rd.
Redwood City, CA 94062

RE: ARBORIST REPORT

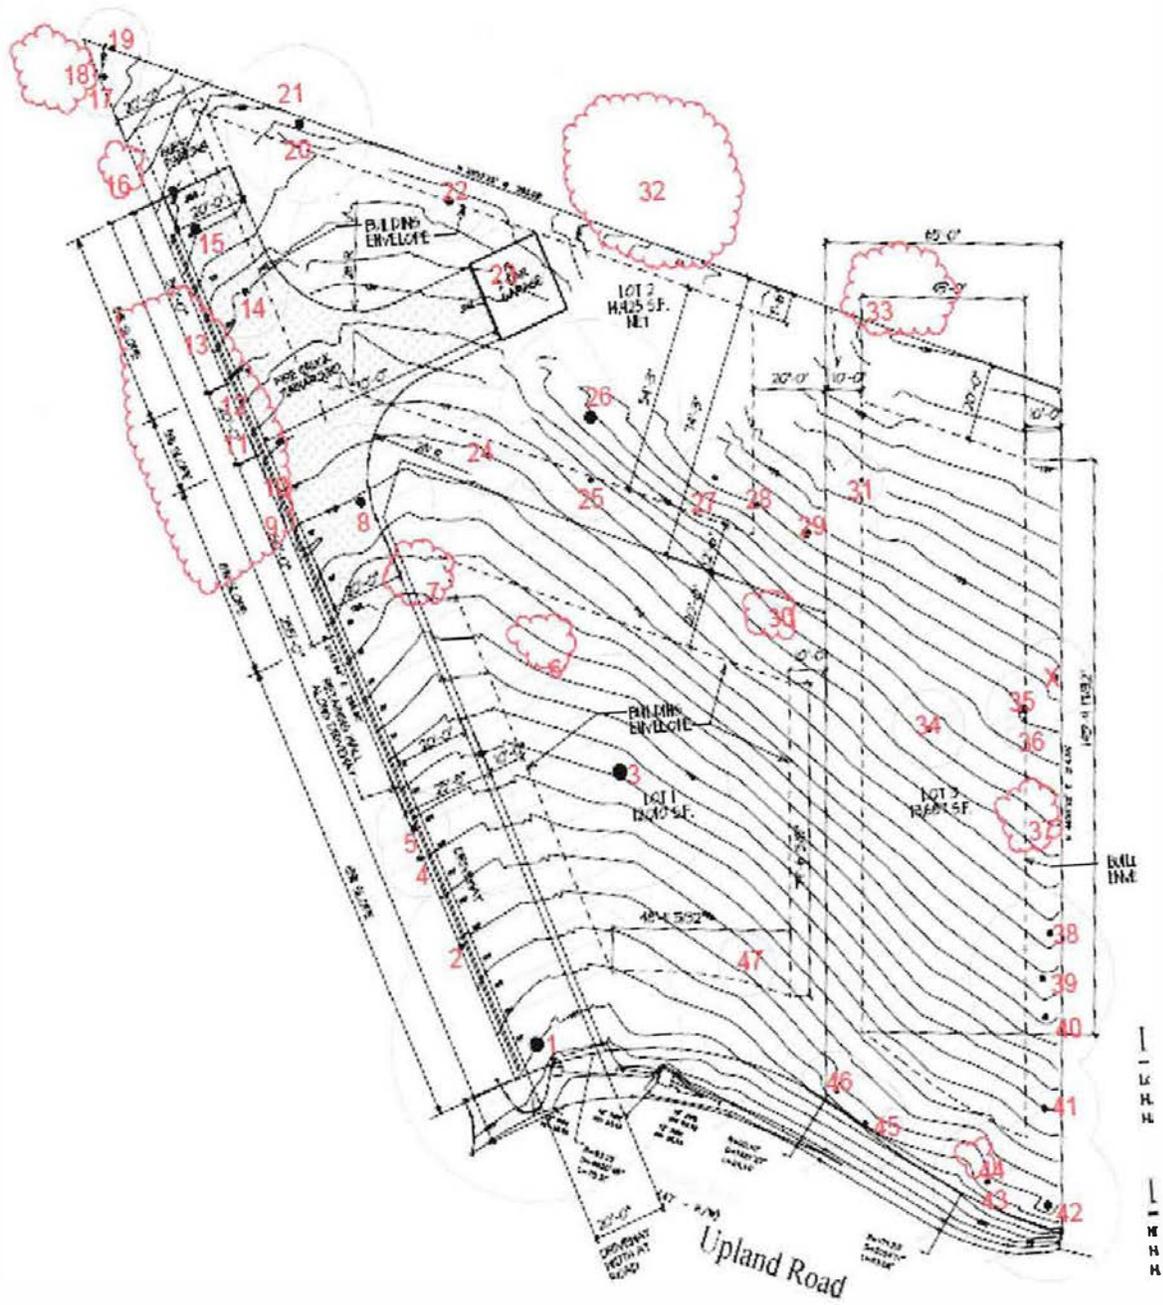
Tree #1 is a Red Gum Eucalyptus located near the front left corner of the property. Soil and other organic material cover the root crown. There is a cavity at 5 feet on the east side of the trunk that is partially filled with broken glass from an art installation. It has multiple attachments at 10 feet, heavy lateral limbs, and a moderate amount of interior deadwood. The canopy is partially growing over high voltage lines it has fair vigor and poor form.

I recommend routine pruning that should include end weight reduction, deadwood removal and removal of the glass from the cavity. It is a good idea to contact the utility provider about fire hazards associated with Eucalyptus trees. This tree is a good candidate for routine pruning or removal by the vegetation management division of the utility service.
